## General Information

| Make | Toyota | Model | Vios |
| YOM | 2025 | Odo Meter Reading | 19,389 |

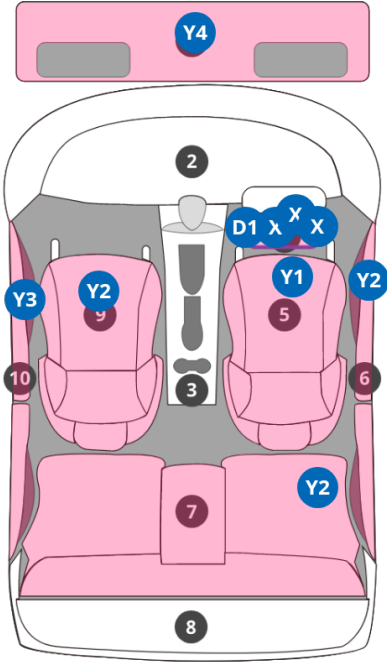
| Interior Evaluation : <span style="color: red;">C</span> | Exterior Evaluation : <span style="color: red;">C</span> |
|---|---|
| <p><b>Remarks</b></p> <p>Ceiling - Grime - Large / Rear Seat - Grime - Small / (R) Front Trim - Grime - Small / (R) Front Seat - Grime - Minimal / (R) Front Floor Mat - Missing - Yes / (L) Front Floor Mat - Missing - Yes / Mat Other - Missing - Yes / (L) Front Trim - Grime - Medium / (L) Front Seat - Grime - Small / Carpet - Worked - Minimal</p> | <p><b>Remarks</b></p> <p>Front Windshield - Damaged - Large / (R) Front Fender, Molding - Scratch - Minimal / (R) Front Door, Molding - Scratch - Minimal / (R) Step, In-panel, Side Spoiler - Scratch - Minimal / (R) Rear Door, Molding - Scratch - Minimal / Rear Bumper, Lamps, Panels - Scratch - Large / (L) Rear Fender, Molding - Scratch - Minimal / (L) Rear Door, Molding - Scratch - Minimal / (L) Step, In-panel, Side Spoiler - Scratch - Minimal / (L) Front Door, Molding - Scratch &amp; Dent - Small / (L) Front Fender, Molding - Dent - Medium / Front Bumper, Grille, Lamps - Scratch - Small / Bonnet, Headlight - Scratch - Minimal / (R) Rear Fender, Molding - Scratch &amp; Dent - Small / Trunk Hood, Rear Gate - Scratch &amp; Dent - Small</p> |

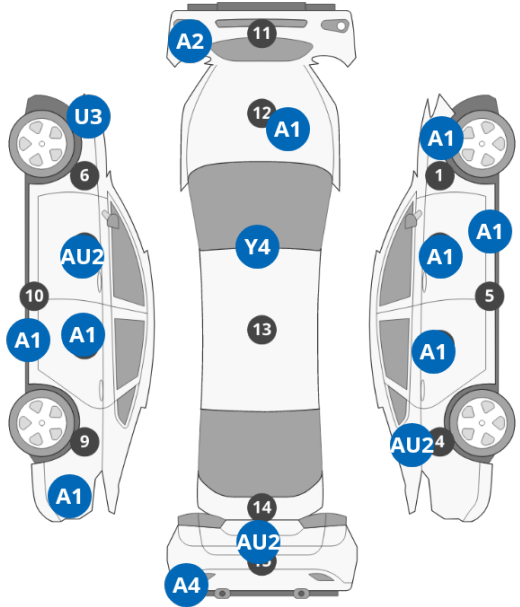
| Inspector Notes |
|---|
| With Lto plate, with spare tire and tools and Jack, 2keys, no warranty booklet, scratches on headlights and taillights, Crack windshield |
