## General Information

| Make | Toyota | Model | Vios |
| Registration No. | CBB6189 | Chassis No. | PA1B18F39P4232416 |

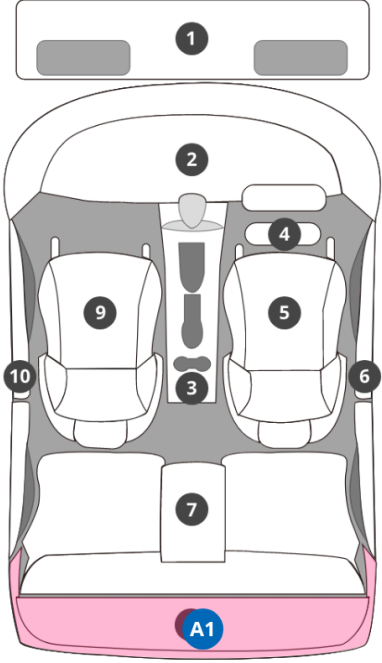
| <b>Interior Evaluation :</b> <span style="color: red; font-weight: bold;">A</span> | <b>Exterior Evaluation :</b> <span style="color: red; font-weight: bold;">B</span> |
| <b>Remarks</b><br>Trunk Room - Worn, Scratch, Cut, Crack - Minimal | <b>Remarks</b><br>(R) Rear Fender, Molding - Scratch - Small / Rear Bumper, Lamps, Panels - Scratch - Medium / (L) Front Fender, Molding - Scratch - Minimal / Front Bumper, Grille, Lamps - Scratch - Minimal / Bonnet, Headlight - Scratch - Small / (R) Front Door, Molding - Scratch - Medium / Roof - Dent - Minimal / (R) Front Fender, Molding - Scratch - Minimal / (L) Rear Fender, Molding - Scratch - Minimal |
