## General Information

| Make | Toyota | Model | Avanza |

## Body / Panel Condition

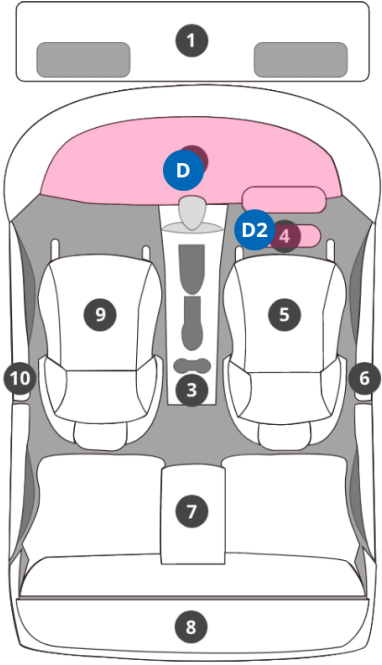
| Interior Evaluation : <span style="color: red; font-weight: bold;">A</span> | Exterior Evaluation : <span style="color: red; font-weight: bold;">E</span> |
|---|---|
| <b>Remarks</b><br>Dashboard - Traces of Adhesive Tape - Yes / (L) Front Floor Mat - Worked - Small | <b>Remarks</b><br>(L) Front Fender - Repair Traces - Yes / (L) Rear Door, Molding - Scratch & Dent - Large / (L) Rear Fender, Molding - Dent - Small / Rear Bumper, Lamps, Panels - Scratch & Dent - Medium / (R) Rear Door, Molding - Dent - Small / (R) Front Door, Molding - Scratch & Dent - Medium / (R) Front Fender, Molding - Scratch & Dent - Large / Front Bumper, Grille, Lamps - Repair mark - Yes / (L) Front Fender, Molding - Repair mark - Yes / Bonnet, Headlight - Scratch & Dent - Medium / (L) Front Fender, Molding - Crack, Gap - Large / Front Bumper, Grille, Lamps - Scratch & Dent - Small / (L) Front Door, Molding - Scratch - Large / Roof - Dent - Medium |
