## General Information

| Make | Toyota | Model | Hilux Tamaraw |
| Registration No. | NLB5856 | Chassis No. | PAHACACA7S6430328 |

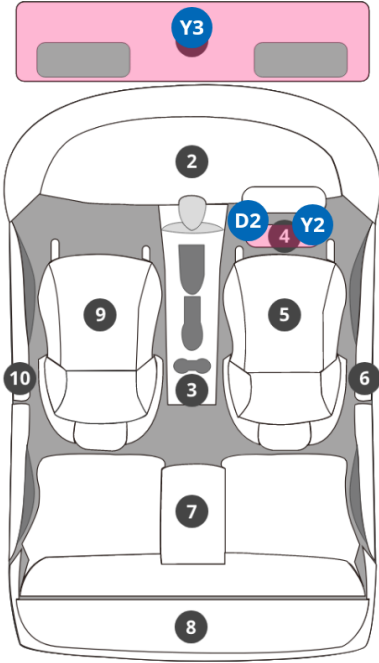
| Interior Evaluation : <b>B</b> | Exterior Evaluation : <b>C</b> |
|---|---|
| <b>Remarks</b><br>(R) Front Floor Mat - Grime - Small / Ceiling - Grime - Medium / (L) Front Floor Mat - Worked - Small | <b>Remarks</b><br>(R) Side Gate - Scratch & Dent - Large / Rear Gate - Scratch - Small / Rear Bumper, Lamps, Panels - Scratch - Small / (L) Front Door, Molding - Scratch - Minimal / Bonnet, Headlight - Scratch - Small / Front Bumper, Grille, Lamps - Scratch & Dent - Medium / (R) Front Fender, Molding - Scratch - Small / (R) Front Door, Molding - Scratch - Small / Roof - Scratch & Dent - Small / (L) Side Gate - Scratch - Medium |
