## General Information

| Make | Toyota | Model | Hilux Tamaraw |
| YOM | 2025 | Odo Meter Reading | 36,566 |
| Registration No. | NJC9218 | Chassis No. | PAHACACA3S6425661 |

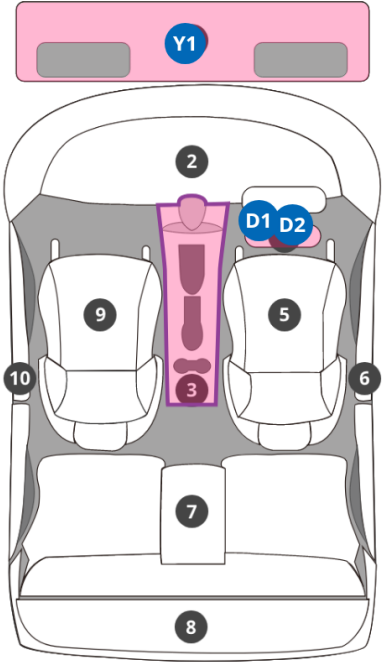
| Interior Evaluation : <b>B</b> | Exterior Evaluation : <b>C</b> |
| <p><b>a</b> : Cut, Fray <b>d</b> : Loose, Deformed <b>k</b> : Animal Hair <b>s</b> : Smell <b>t</b> : Cigarette Burns <b>x</b> : Defective <b>y</b> : Stain</p> | <p><b>A</b> : Scratch <b>AU</b> : Scratch &amp; Dent <b>B</b> : Modified <b>C</b> : Corrosion <b>G</b> : Stone chip <b>P</b> : Faded <b>S</b> : Rust <b>SC</b> : Rust &amp; Corrosion <b>U</b> : Dent <b>X</b> : Defective <b>Y</b> : Crack, Gap</p> |
| <b>Remarks</b><br>Ceiling - Grime - Minimal / Display, Audio System - Missing - Yes / (L) Front Floor Mat - Worked - Small / Carpet - Worked - Minimal | <b>Remarks</b><br>(R) Front Fender, Molding - Scratch - Minimal / (R) Mirror - Scratch - Minimal / (R) Front Door, Molding - Scratch - Small / (R) Step, In-panel, Side Spoiler - Scratch - Minimal / (R) Side Gate - Scratch - Large / Rear Bumper, Lamps, Panels - Scratch - Minimal / Cab Back Panel - Scratch - Large / (L) Side Gate - Scratch & Dent - Small / Roof - Scratch & Dent - Medium / (L) Front Door, Molding - Scratch - Minimal / (L) Mirror - Scratch - Minimal / (L) Step, In-panel, Side Spoiler - Scratch - Minimal / (L) Front Fender, Molding - Scratch - Minimal / Front Bumper, Grille, Lamps - Scratch - Small / Bonnet, Headlight - Scratch - Minimal |

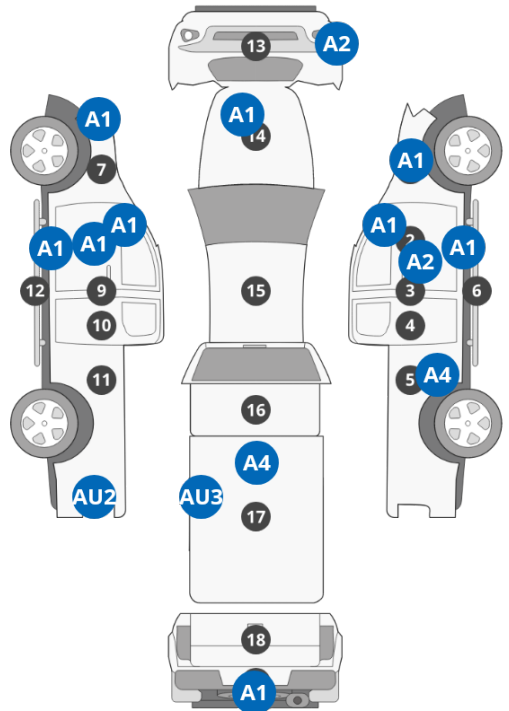
With Lto plate, with spare tire and jack, with warranty booklet, 1key, scratches on headlights, no Rear door key
