## General Information

| Make | Toyota | Model | Vios |
| Registration No. | DCE4016 | Chassis No. | PA1B18F34S4306656 |

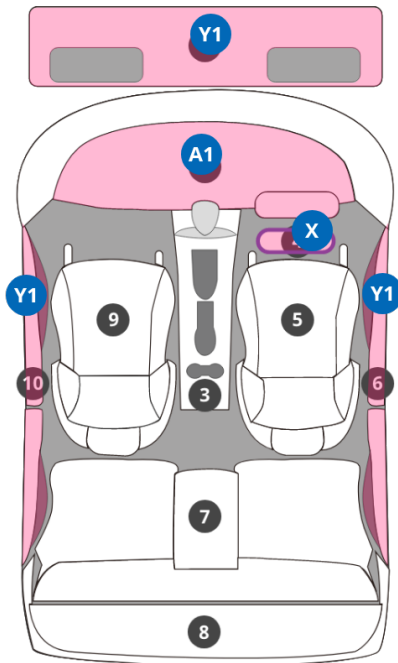
| Interior Evaluation : <b>B</b> | Exterior Evaluation : <b>B</b> |
|---|---|
| <p><b>Remarks</b><br/>Ceiling - Grime - Minimal / Mat Other - Missing - Yes / (R) Front Trim - Grime - Minimal / (L) Front Trim - Grime - Minimal / Dashboard - Worn, Scratch, Cut, Crack - Minimal</p> | <p><b>Remarks</b><br/>(R) Front Fender, Molding - Scratch - Minimal / (R) Front Door, Molding - Scratch - Minimal / (R) Step, In-panel, Side Spoiler - Scratch - Minimal / (R) Rear Door, Molding - Scratch - Minimal / (R) Rear Fender, Molding - Scratch - Minimal / Rear Bumper, Lamps, Panels - Scratch - Minimal / Trunk Hood, Rear Gate - Scratch - Minimal / (L) Rear Fender, Molding - Scratch - Minimal / (L) Rear Door, Molding - Scratch - Minimal / (L) Front Door, Molding - Scratch - Minimal / (L) Front Fender, Molding - Scratch - Minimal / Front Bumper, Grille, Lamps - Scratch - Minimal / Bonnet, Headlight - Scratch - Minimal / Roof - Scratch - Minimal / (L) Step, In-panel, Side Spoiler - Scratch - Minimal</p> |

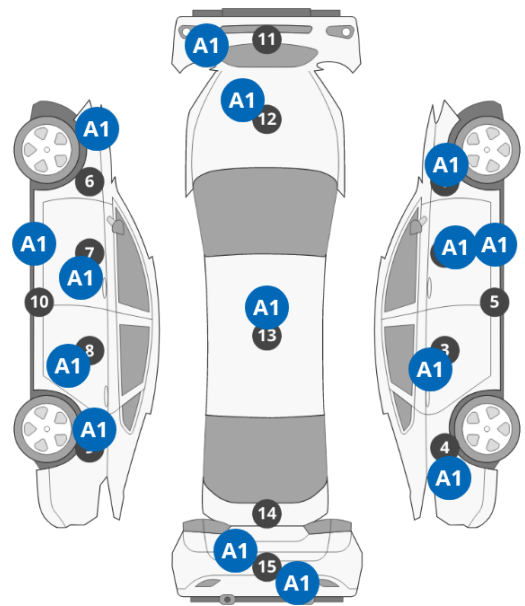
With Lto plate, with warranty booklet and jack, 3keys, no spare tire and tools, scratches on headlights and taillights,check engine warning lamp on, traction control lamp on, maintenance warning lamp on,
