## General Information

| Make | Toyota | Model | Vios |
| Registration No. | NHS1731 | Chassis No. | PA1B18F37P4233676 |

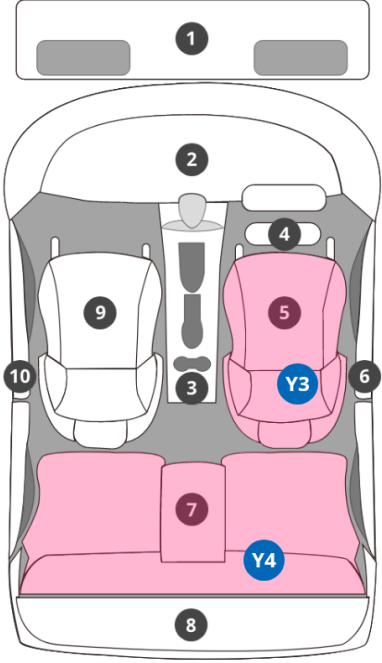
| Interior Evaluation : <span style="color: red;">C</span> | Exterior Evaluation : <span style="color: red;">C</span> |
|---|---|
| <b>Remarks</b><br>(R) Front Seat - Grime - Medium / Rear Seat - Grime - Large | <b>Remarks</b><br>Front Bumper, Grille, Lamps - Crack, Gap - Large / Bonnet, Headlight - Scratch & Dent - Medium / (L) Front Door, Molding - Scratch - Small / Member (Bolted) - Dent - Yes / (R) Front Door, Molding - Dent - Medium / Rear Bumper, Lamps, Panels - Scratch - Small / (R) Rear Fender, Molding - Scratch - Small / (R) Rear Door, Molding - Scratch - Small |
