## General Information

| Make | Toyota | Model | Vios |

## Body / Panel Condition

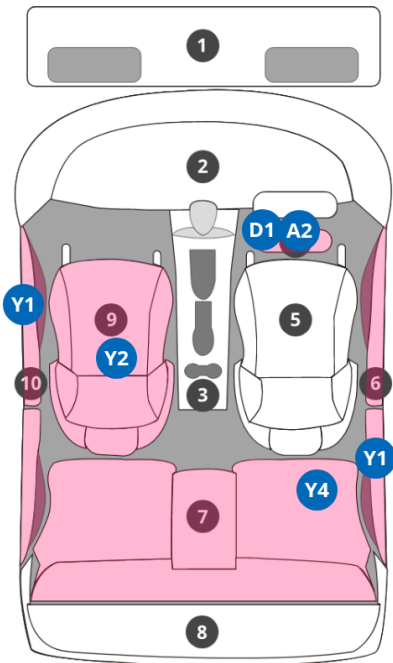
| Interior Evaluation : <span style="color: red; font-weight: bold;">C</span> | | Exterior Evaluation : <span style="color: red; font-weight: bold;">B</span> | |
| <p><b>Remarks</b></p> <p>Rear Seat - Grime - Large / (R) Rear Trim - Grime - Minimal / (L) Front Trim - Grime - Minimal / (L) Front Floor Mat - Cut, Crack - Small / Carpet - Worked - Minimal / (L) Front Seat - Grime - Small</p> | | <p><b>Remarks</b></p> <p>(R) Front Fender, Molding - Scratch - Minimal / (R) Front Door, Molding - Scratch - Minimal / (R) Step, In-panel, Side Spoiler - Scratch - Minimal / (R) Rear Door, Molding - Scratch - Minimal / (R) Rear Fender, Molding - Scratch - Minimal / Rear Bumper, Lamps, Panels - Scratch - Minimal / Trunk Hood, Rear Gate - Scratch - Minimal / (L) Rear Fender, Molding - Scratch - Minimal / (L) Rear Door, Molding - Scratch - Minimal / (L) Front Door, Molding - Scratch - Minimal / (L) Step, In-panel, Side Spoiler - Scratch &amp; Dent - Medium / (L) Front Fender, Molding - Scratch - Small / (L) Mirror - Scratch - Minimal / Front Bumper, Grille, Lamps - Scratch - Minimal / Bonnet, Headlight - Scratch - Minimal</p> | |
