## General Information

| Make | Toyota | Model | Vios |
| Registration No. | NKI7223 | Chassis No. | PA1B18F35R4262791 |

## Body / Panel Condition

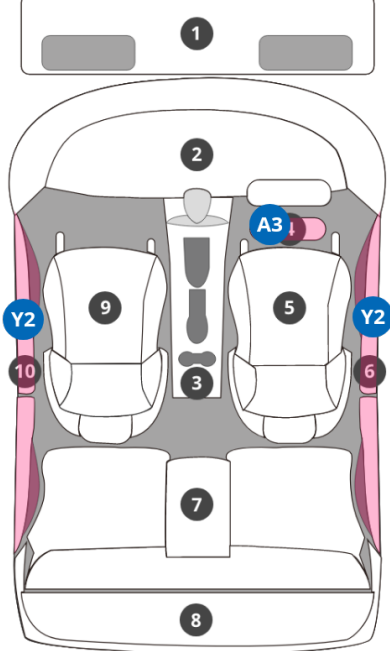
| Interior Evaluation : <b>B</b> | Exterior Evaluation : <b>E</b> |
|---|---|
| <p><b>Remarks</b><br/>(L) Front Trim - Grime - Small / (R) Front Trim - Grime - Small / (L) Front Floor Mat - Cut, Crack - Medium</p> | <p><b>Remarks</b><br/>(R) Front Door - Repair Traces - Yes / (R) Step - Repair Traces - Yes / (L) Front Fender - Repair Traces - Yes / (L) Front Door - Repair Traces - Yes / (L) Step - Repair Traces - Yes / (L) Rear Door - Repair Traces - Yes / (R) Rear Fender - Repair Traces - Yes / (R) Rear Door - Repair Traces - Yes / Bonnet, Headlight - Scratch &amp; Dent - Small / Front Bumper, Grille, Lamps - Scratch &amp; Dent - Large / (R) Front Door, Molding - Scratch &amp; Dent - Small / (R) Step, In-panel, Side Spoiler - Scratch &amp; Dent - Large / (R) Rear Door, Molding - Scratch - Large / (R) Rear Fender, Molding - Crack, Gap - Medium / Trunk Hood, Rear Gate - Dent - Medium / Rear Bumper, Lamps, Panels - Scratch &amp; Dent - Large / (L) Rear Door, Molding - Scratch - Large / (L) Front Door, Molding - Crack, Gap - Large / (L) Front Fender, Molding - Scratch - Small / (L) Rear Fender, Molding - Scratch - Small / (R) Front Fender, Molding - Scratch - Small</p> |
