## General Information

| Make | Toyota | Model | Vios |
| YOM | 2024 | Odo Meter Reading | 14,390 |

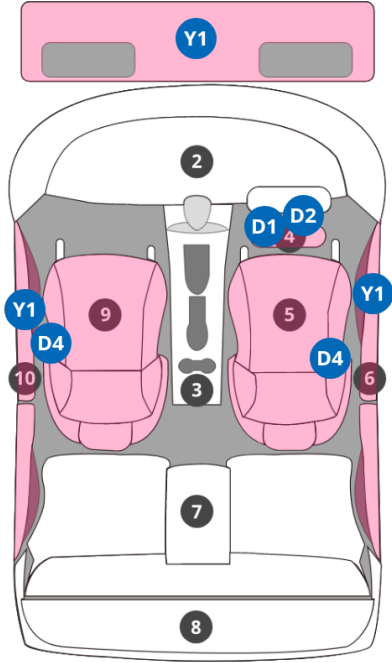
| Interior Evaluation : <span style="color: red;">C</span> | Exterior Evaluation : <span style="color: red;">C</span> |
|---|---|
| <p><b>Remarks</b><br/>Ceiling - Grime - Minimal / (R) Front Trim - Grime - Minimal / (L) Front Trim - Grime - Minimal / (L) Front Floor Mat - Worked - Small / Carpet - Worked - Minimal / (R) Front Seat belt - Loose, Deformed - Large / (L) Front Seat belt - Loose, Deformed - Large</p> | <p><b>Remarks</b><br/>(R) Front Fender, Molding - Scratch - Minimal / (R) Mirror - Scratch - Minimal / (R) Front Door, Molding - Scratch - Small / (R) Step, In-panel, Side Spoiler - Scratch - Minimal / (R) Rear Fender, Molding - Scratch - Medium / (R) Rear Door, Molding - Scratch - Medium / Rear Bumper, Lamps, Panels - Scratch - Minimal / Trunk Hood, Rear Gate - Scratch - Minimal / (L) Rear Fender, Molding - Scratch - Minimal / (L) Rear Door, Molding - Scratch - Small / (L) Step, In-panel, Side Spoiler - Scratch - Minimal / (L) Front Door, Molding - Scratch - Minimal / (L) Front Fender, Molding - Scratch - Minimal / Front Bumper, Grille, Lamps - Scratch - Small / Bonnet, Headlight - Scratch - Small / Roof - Scratch - Minimal</p> |

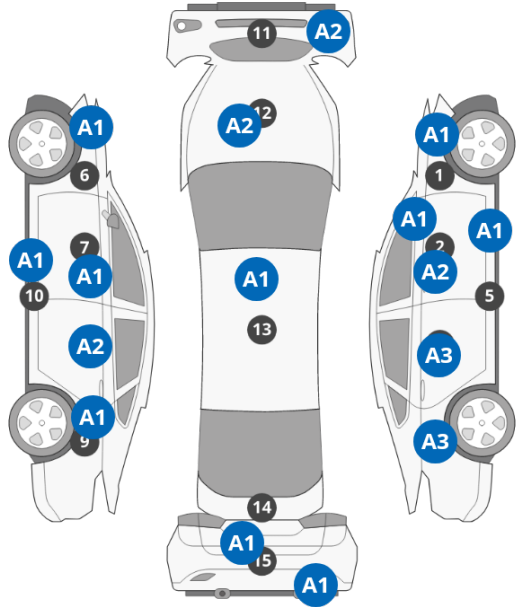
| Inspector Notes |
|---|
| With Lto plate, with warranty booklet and tools and Jack, 2keys, no spare tire, scratches on headlights, airbag warning lamp on, abs warning lamp on, traction control lamp on, |
