## General Information

| Make | Chevrolet | Model | Captiva |
| YOM | 2011 | Odo Meter Reading | 124,693 |
| Registration No. | TZI409 | Chassis No. | KL1CA26R1BH304487 |

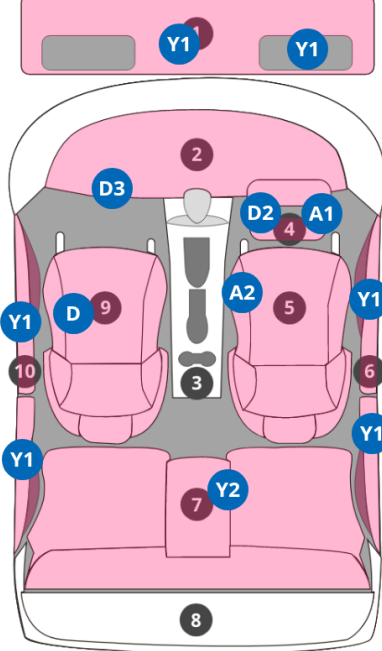
| Interior Evaluation : <span style="color: red;">C</span> | Exterior Evaluation : <span style="color: red;">E</span> |
| <p><b>Remarks</b></p> <p>Rear Seat - Grime - Small / (R) Rear Trim - Grime - Minimal / (R) Front Trim - Grime - Minimal / (L) Rear Trim - Grime - Minimal / (L) Front Trim - Grime - Minimal / (R) Front Seat - Cut, Crack - Small / (L) Front Seat - Worn - Yes / (R) Front Floor Mat - Cut, Crack - Minimal / (L) Front Floor Mat - Worked - Small / Dashboard - Loose, Deformed - Medium / Ceiling - Grime - Minimal / Sunvisor, Sunglass Holder - Grime - Minimal / Overall Interior - Worn as per age - Yes</p> | <p><b>Remarks</b></p> <p>(R) Front Door - Repair Traces - Yes / (R) Front Fender - Repair Traces - Yes / Bonnet - Repair Traces - Yes / (L) Front Fender - Repair Traces - Yes / (L) Front Door - Repair Traces - Yes / (L) Rear Door - Repair Traces - Yes / (L) Rear Fender - Repair Traces - Yes / Trunk Hood, Rear Gate - Repair Traces - Yes / (R) Rear Fender - Repair Traces - Yes / (R) Rear Door - Repair Traces - Yes / Roof - Repair Traces - Yes / (R) Front Door, Molding - Repair mark - Yes / (R) Rear Door, Molding - Repair mark - Yes / (R) Rear Fender, Molding - Repair mark - Yes / Trunk Hood, Rear Gate - Repair mark - Yes / Roof - Repair mark - Yes / (L) Front Fender, Molding - Repair mark - Yes / (L) Rear Fender, Molding - Repair mark - Yes / Front Bumper, Grille, Lamps - Scratch - Small / (R) Front Fender, Molding - Scratch - Small / (R) Mirror - Crack - Damaged / (R) Front Door, Molding - Scratch - Small / (R) Rear Door, Molding - Scratch - Small / (R) Step, In-panel, Side Spoiler - Scratch - Small / (R) Rear Fender, Molding - Scratch - Small / Roof - Dent - Small / Trunk Hood, Rear Gate - Scratch - Small / Rear Bumper, Lamps, Panels - Scratch - Small / (L) Rear Fender, Molding - Scratch - Large / (L) Rear Door, Molding - Scratch - Small / (L) Step, In-panel, Side Spoiler - Scratch - Small / (L) Front Door, Molding - Scratch - Small / (L) Mirror - Crack - Cracks / (L) Front Fender, Molding - Scratch - Small / Bonnet, Headlight - Scratch - Small / Overall Exterior - Worn as per age - Yes</p> |
