## General Information

| Make | Toyota | Model | Vios |
| YOM | 2024 | Odo Meter Reading | 50,724 |

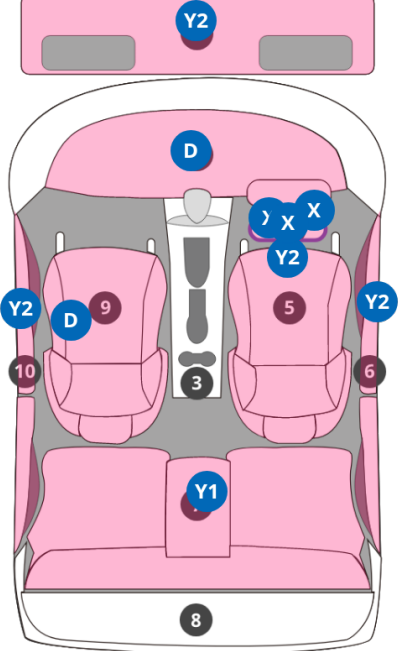
| Interior Evaluation : <b>B</b> | Exterior Evaluation : <b>E</b> |
| <p><b>Remarks</b></p> <p>Dashboard - Traces of Adhesive Tape - Yes / (L) Front Seat - Worn - Yes / (R) Front Seat - Grime - Small / (L) Front Trim - Grime - Small / (R) Front Trim - Grime - Small / Rear Seat - Grime - Minimal / Ceiling - Grime - Small / (L) Front Floor Mat - Missing - Yes / (R) Front Floor Mat - Missing - Yes / Mat Other - Missing - Yes</p> | <p><b>Remarks</b></p> <p>Member (Bolted) - Dent - Yes / (R) Front Fender, Molding - Scratch - Medium / (R) Mirror - Scratch - Minimal / (R) Front Door, Molding - Scratch - Small / (R) Rear Door, Molding - Scratch - Medium / (R) Rear Fender, Molding - Scratch - Small / Trunk Hood, Rear Gate - Crack, Gap - Large / Rear Bumper, Lamps, Panels - Crack, Gap - Medium / (L) Rear Fender, Molding - Scratch - Small / (L) Rear Door, Molding - Scratch - Small / (L) Front Door, Molding - Scratch - Medium / (L) Mirror - Scratch - Small / (L) Front Fender, Molding - Scratch - Small / Front Bumper, Grille, Lamps - Scratch - Medium / Bonnet, Headlight - Crack, Gap - Medium / Roof - Scratch &amp; Dent - Small</p> |

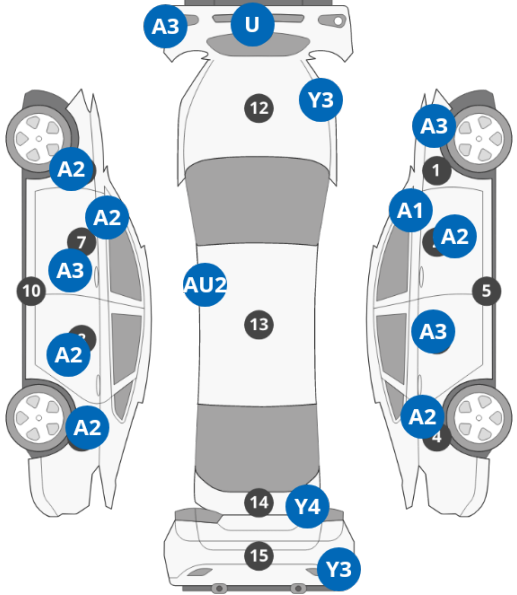
| Inspector Notes |
|---|
| no warranty booklet, with jack, incomplete tools, with spare tire, with LTO plate, scratches on tail light, repair marks on tail light, engine under cover missing, rear right fender traces of bending |
