## General Information

| Make | Toyota | Model | Vios |
| Registration No. | NJK1646 | Chassis No. | PA1B18F35S4297899 |

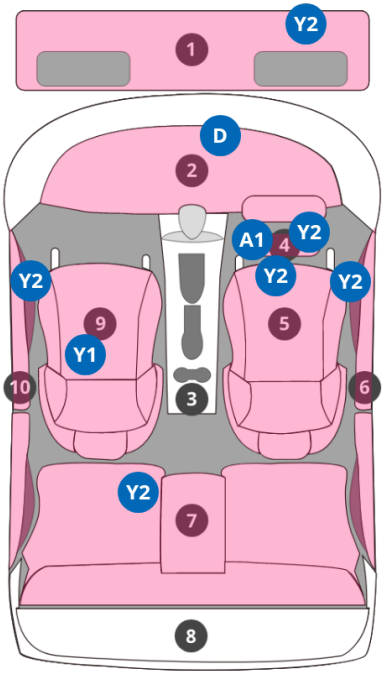
| Interior Evaluation : <b>B</b> | Exterior Evaluation : <b>B</b> |
| <b>Remarks</b><br>Dashboard - Traces of Adhesive Tape - Yes / (L) Front Floor Mat - Cut, Crack - Minimal / (R) Front Floor Mat - Grime - Small / (R) Front Seat - Grime - Small / (L) Front Seat - Grime - Minimal / (L) Front Trim - Grime - Small / (R) Front Trim - Grime - Small / Ceiling - Grime - Small / Rear Seat - Grime - Small | <b>Remarks</b><br>(R) Front Fender, Molding - Scratch - Minimal / (R) Front Door, Molding - Scratch - Small / (R) Rear Door, Molding - Scratch - Small / (R) Rear Fender, Molding - Scratch - Minimal / Rear Bumper, Lamps, Panels - Scratch - Minimal / Trunk Hood, Rear Gate - Scratch - Minimal / (L) Rear Fender, Molding - Scratch - Minimal / (L) Rear Door, Molding - Scratch - Minimal / (L) Front Door, Molding - Scratch - Minimal / (L) Step, In-panel, Side Spoiler - Scratch - Minimal / (R) Step, In-panel, Side Spoiler - Scratch - Minimal / (L) Front Fender, Molding - Scratch - Minimal / Bonnet, Headlight - Scratch - Minimal / Front Bumper, Grille, Lamps - Scratch - Small / Roof - Scratch - Minimal |
