## General Information

| Make | Toyota | Model | Vios |

## Body / Panel Condition

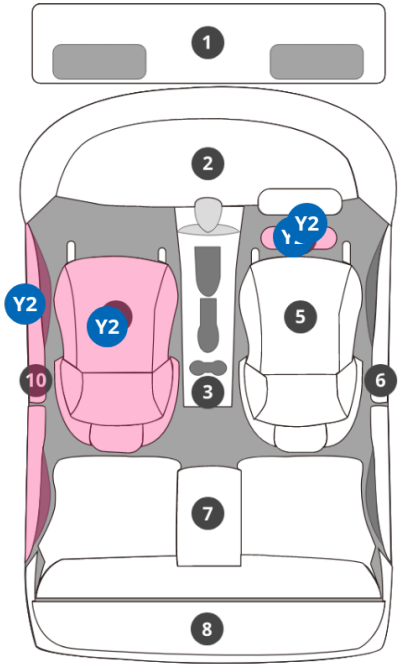
| Interior Evaluation : <b>A</b> | Exterior Evaluation : <b>E</b> |
| <p><b>Remarks</b><br/>(L) Front Floor Mat - Grime - Small / (R) Front Floor Mat - Grime - Small / (L) Front Seat - Grime - Small / (L) Front Trim - Grime - Small</p> | <p><b>Remarks</b><br/>(R) Front Fender - Repair Traces - Yes / Bonnet - Repair Traces - Yes / (L) Front Fender - Repair Traces - Yes / (L) Rear Fender, Molding - Scratch &amp; Dent - Small / (L) Rear Door, Molding - Scratch &amp; Dent - Minimal / (L) Front Door, Molding - Scratch &amp; Dent - Minimal / (L) Front Door, Molding - Modified - Large / Roof - Scratch &amp; Dent - Minimal / (L) Step, In-panel, Side Spoiler - Modified - Large / (L) Front Fender, Molding - Scratch &amp; Dent - Small / Bonnet, Headlight - Scratch &amp; Dent - Minimal / Front Bumper, Grille, Lamps - Scratch - Medium / (R) Front Fender, Molding - Scratch &amp; Dent - Small / (R) Front Door, Molding - Modified - Large / (R) Rear Door, Molding - Scratch &amp; Dent - Small / (R) Step, In-panel, Side Spoiler - Modified - Large / (R) Rear Fender, Molding - Scratch &amp; Dent - Medium / Trunk Hood, Rear Gate - Scratch &amp; Dent - Small / Rear Bumper, Lamps, Panels - Scratch - Medium</p> |

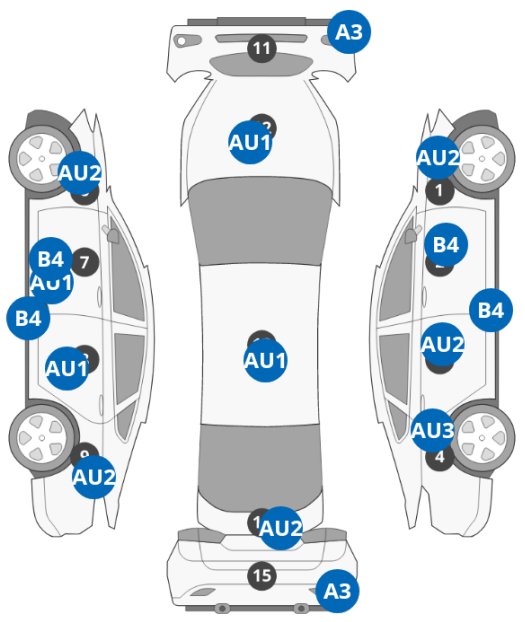
with LTO plate, with spare tire, with warranty and manual booklet, with reverse camera, scratches and dent on exterior, scratches on taillight and headlight, no jack and tools.
