## General Information

| Make | Toyota | Model | Vios |
| YOM | 2025 | Odo Meter Reading | 72,572 |

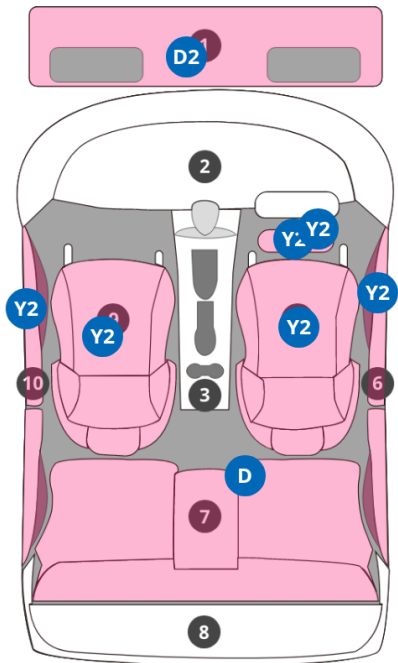
| Interior Evaluation : <b>B</b> | Exterior Evaluation : <b>E</b> |
| <b>Remarks</b><br>(L) Front Floor Mat - Grime - Small / (R) Front Floor Mat - Grime - Small / Rear Seat - Worn - Yes / (R) Front Seat - Grime - Small / (L) Front Seat - Grime - Small / (L) Front Trim - Grime - Small / (R) Front Trim - Grime - Small / Ceiling - Crinkle - Small | <b>Remarks</b><br>(R) Front Fender - Repair Traces - Yes / Bonnet - Repair Traces - Yes / (L) Front Fender - Repair Traces - Yes / (L) Rear Door - Repair Traces - Yes / Trunk Hood, Rear Gate - Repair Traces - Yes / Bonnet, Headlight - Scratch & Dent - Small / (L) Front Fender, Molding - Scratch & Dent - Medium / Front Bumper, Grille, Lamps - Scratch - Medium / (R) Front Fender, Molding - Scratch & Dent - Medium / (R) Rear Door, Molding - Scratch - Medium / (R) Front Door, Molding - Scratch & Dent - Medium / (R) Step, In-panel, Side Spoiler - Scratch & Dent - Small / (R) Rear Fender, Molding - Scratch & Dent - Small / Roof - Scratch & Dent - Small / Rear Bumper, Lamps, Panels - Scratch - Medium / Rear Bumper, Lamps, Panels - Repair mark - Yes / (L) Rear Fender, Molding - Repair mark - Yes / (L) Rear Door, Molding - Repair mark - Yes / (L) Rear Door, Molding - Scratch & Dent - Small / (L) Rear Fender, Molding - Scratch & Dent - Small / (L) Step, In-panel, Side Spoiler - Scratch & Dent - Small / (L) Front Door, Molding - Scratch & Dent - Small / Trunk Hood, Rear Gate - Scratch & Dent - Small |

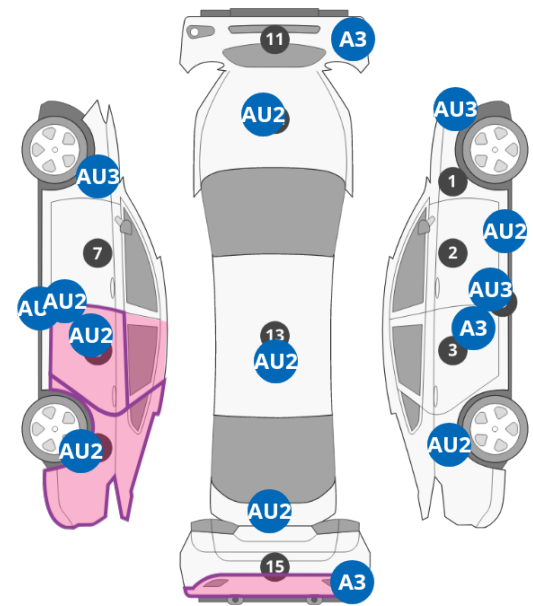
with LTO plate, with spare tire, with manual booklet, with reverse camera, no tools and jack, no spare key, no warranty booklet, no aircon issue, scratches and dent on exterior, scratches on taillight and headlight, issue on plate light, trunk tire cover missing.
