## General Information

| Make | Toyota | Model | Vios |
| YOM | 2025 | Odo Meter Reading | 10,358 |
| Registration No. | DCA3300 | Chassis No. | PA1B18F39S4292155 |

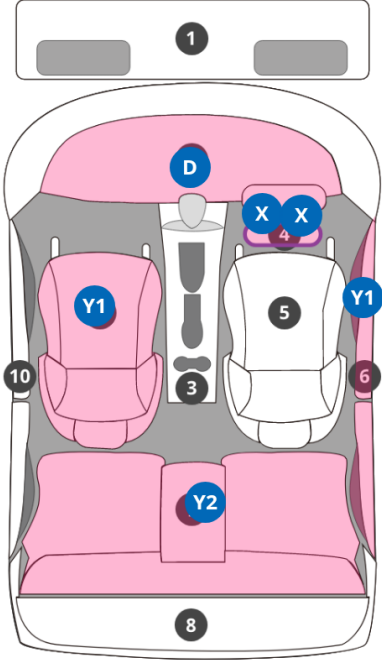
| Interior Evaluation : <b>B</b> | Exterior Evaluation : <b>B</b> |
|---|---|
| <p><b>Remarks</b><br/>(L) Front Seat - Grime - Minimal / (L) Front Floor Mat - Missing - Yes / (R) Front Floor Mat - Missing - Yes / Mat Other - Missing - Yes / (R) Front Trim - Grime - Minimal / Dashboard - Traces of Adhesive Tape - Yes / Rear Seat - Grime - Small</p> | <p><b>Remarks</b><br/>(R) Front Fender - Repair Traces - Yes / Bonnet - Repair Traces - Yes / (L) Front Fender - Repair Traces - Yes / (L) Rear Fender, Molding - Scratch &amp; Dent - Minimal / (L) Rear Door, Molding - Scratch &amp; Dent - Minimal / (L) Front Door, Molding - Scratch &amp; Dent - Minimal / Roof - Scratch &amp; Dent - Minimal / (L) Front Fender, Molding - Scratch - Minimal / Front Bumper, Grille, Lamps - Scratch - Medium / (R) Front Door, Molding - Scratch &amp; Dent - Small / (R) Rear Door, Molding - Scratch &amp; Dent - Minimal / Rear Bumper, Lamps, Panels - Scratch - Medium / (R) Rear Fender, Molding - Scratch &amp; Dent - Minimal / Trunk Hood, Rear Gate - Scratch &amp; Dent - Minimal / Bonnet, Headlight - Scratch &amp; Dent - Minimal / (R) Front Fender, Molding - Scratch &amp; Dent - Minimal</p> |

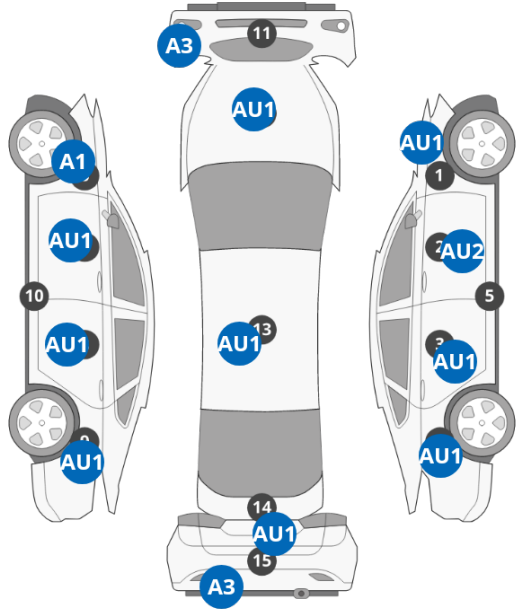
| Inspector Notes |
|---|
| <p>with LTO plate, with spare tire and key, with reverse camera, with manual and warranty booklet, with jack, no tools, scratches on taillight and headlight, minor scratches and dent on exterior.</p> |
