## General Information

| Make | Toyota | Model | Avanza |
| Registration No. | GBJ2461 | Chassis No. | MHFAA1BY8R0035199 |

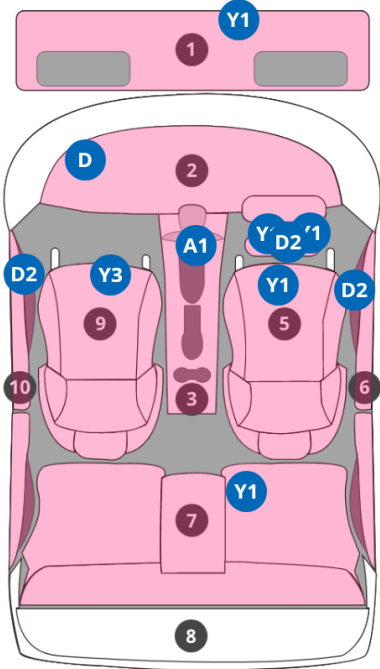
| Interior Evaluation : <span style="color: red;">B</span> | Exterior Evaluation : <span style="color: red;">B</span> |
| <p><b>Remarks</b></p> <p>Dash-board - Traces of Adhesive Tape - Yes / (R) Front Floor Mat - Grime - Minimal / (L) Front Floor Mat - Grime - Minimal / (L) Front Seat - Grime - Medium / Mat Other - Worked - Small / (R) Front Seat - Grime - Minimal / Rear Seat - Grime - Minimal / Ceiling - Grime - Minimal / (L) Front Trim - Worked - Small / (R) Front Trim - Worked - Small / Console, Switchs, Vents - Worn, Scratch, Cut, Crack - Minimal</p> | <p><b>Remarks</b></p> <p>(R) Front Fender, Molding - Scratch - Minimal / (R) Mirror - Scratch, Peeled - Minimal / (R) Front Door, Molding - Scratch - Small / (R) Rear Door, Molding - Scratch - Small / (R) Rear Fender, Molding - Scratch - Minimal / Rear Bumper, Lamps, Panels - Scratch - Minimal / Trunk Hood, Rear Gate - Scratch - Minimal / (L) Rear Fender, Molding - Scratch - Minimal / (L) Rear Door, Molding - Scratch - Minimal / (L) Front Door, Molding - Scratch - Small / (L) Mirror - Scratch - Minimal / (L) Front Fender, Molding - Scratch - Minimal / Front Bumper, Grille, Lamps - Scratch - Small / Bonnet, Headlight - Scratch - Minimal / Roof - Dent - Small / (L) Step, In-panel, Side Spoiler - Scratch - Minimal / (R) Step, In-panel, Side Spoiler - Scratch - Minimal</p> |
