## General Information

| Make | Toyota | Model | Vios |
| Registration No. | DCC5972 | Chassis No. | PA1B18F33S4295942 |

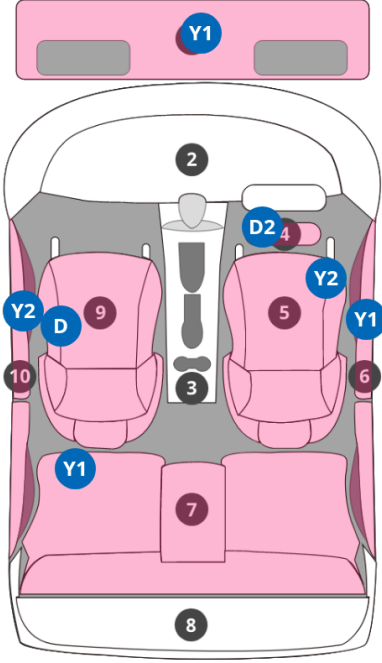
| Interior Evaluation : <b>B</b> | Exterior Evaluation : <b>C</b> |
|---|---|
| <p><b>Remarks</b></p> <p>(L) Front Floor Mat - Worked - Small / (L) Front Seat - Worn - Yes / (R) Front Seat - Grime - Small / (L) Front Trim - Grime - Small / (R) Front Trim - Grime - Minimal / Ceiling - Grime - Minimal / Rear Seat - Grime - Minimal</p> | <p><b>Remarks</b></p> <p>(R) Rear Fender - Repair Traces - Yes / (R) Front Fender, Molding - Scratch - Minimal / (R) Mirror - Scratch - Minimal / (R) Rear Door, Molding - Scratch - Medium / (R) Front Door, Molding - Scratch - Small / (R) Rear Fender, Molding - Scratch &amp; Dent - Small / Rear Bumper, Lamps, Panels - Scratch - Small / Trunk Hood, Rear Gate - Scratch - Minimal / (L) Rear Fender, Molding - Scratch &amp; Dent - Minimal / (L) Rear Door, Molding - Scratch - Small / (L) Front Door, Molding - Scratch - Small / (L) Mirror - Scratch - Minimal / (L) Front Fender, Molding - Scratch - Minimal / Bonnet, Headlight - Scratch - Small / Front Bumper, Grille, Lamps - Scratch - Medium / Roof - Scratch - Minimal</p> |

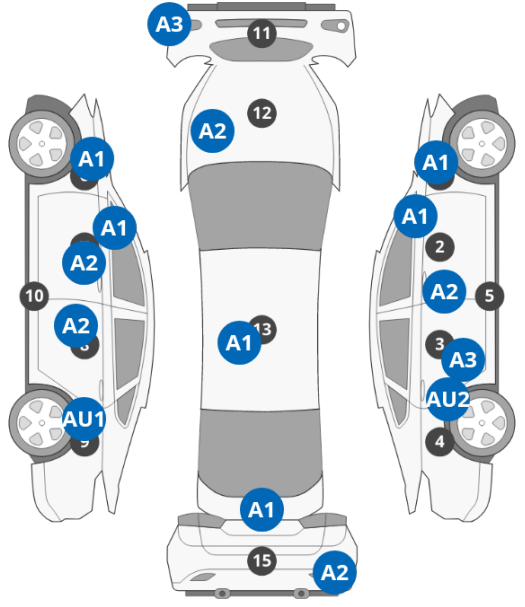
| Inspector Notes |
|---|
| with warranty booklet and jack, incomplete tools, with spare tire, with LTO plate, scratches on tail light |
