## General Information

| Make | Toyota | Model | Avanza |
| Registration No. | DCA4630 | Chassis No. | MHFAA1BY5S0044688 |

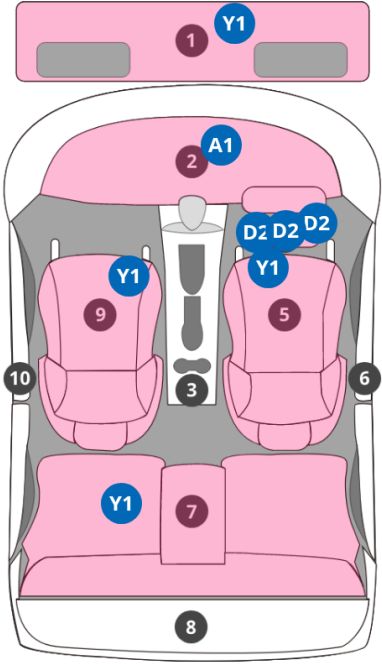
| Interior Evaluation : <b>B</b> | Exterior Evaluation : <b>B</b> |
|---|---|
| <p><b>Remarks</b><br/>Dashboard - Worn, Scratch, Cut, Crack - Minimal / (L) Front Seat - Grime - Minimal / (R) Front Seat - Grime - Minimal / (L) Front Floor Mat - Worked - Small / (R) Front Floor Mat - Worked - Small / Mat Other - Worked - Small / Ceiling - Grime - Minimal / Rear Seat - Grime - Minimal</p> | <p><b>Remarks</b><br/>(R) Front Fender, Molding - Scratch - Minimal / (R) Mirror - Scratch - Minimal / (R) Step, In-panel, Side Spoiler - Scratch - Minimal / (R) Front Door, Molding - Scratch - Minimal / (R) Rear Door, Molding - Scratch &amp; Dent - Medium / (R) Rear Fender, Molding - Scratch &amp; Dent - Minimal / Rear Bumper, Lamps, Panels - Scratch - Minimal / Trunk Hood, Rear Gate - Scratch - Minimal / (L) Rear Fender, Molding - Scratch - Minimal / (L) Rear Door, Molding - Scratch - Minimal / (L) Step, In-panel, Side Spoiler - Scratch - Minimal / (L) Front Door, Molding - Scratch - Minimal / (L) Mirror - Scratch - Minimal / (L) Front Fender, Molding - Scratch - Minimal / Front Bumper, Grille, Lamps - Scratch - Small / Bonnet, Headlight - Scratch - Minimal / Roof - Scratch - Minimal</p> |

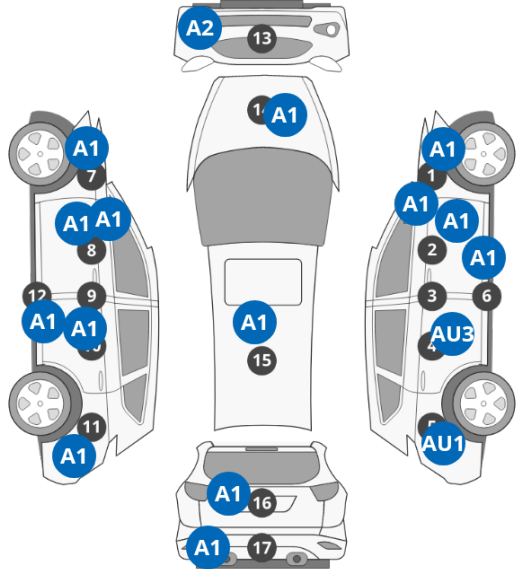
| Inspector Notes |
|---|
| with Ito plate/with warranty booklet/with tools and jack/with spare tire/with hairlines scratches on the body/with reverse camera |
