## General Information

| Make | Toyota | Model | Vios |
| Registration No. | DCD9426 | Chassis No. | PA1B18F38S4300939 |

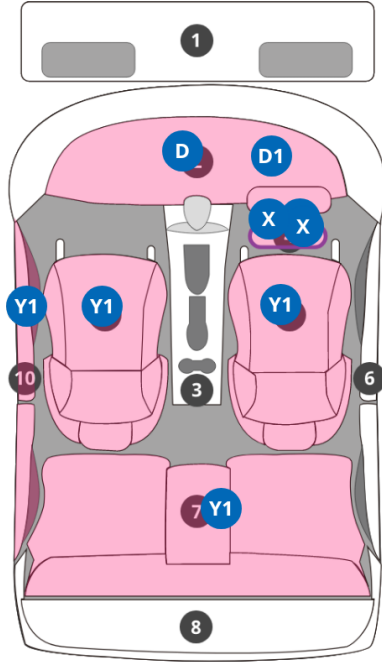
| Interior Evaluation : <b>B</b> | Exterior Evaluation : <b>D</b> |
| <p><b>Remarks</b><br/>(L) Front Floor Mat - Missing - Yes / (R) Front Floor Mat - Missing - Yes / Mat Other - Missing - Yes / Dashboard - Worked - Minimal / (L) Front Trim - Grime - Minimal / (L) Front Seat - Grime - Minimal / (R) Front Seat - Grime - Minimal / Dashboard - Traces of Adhesive Tape - Yes / Rear Seat - Grime - Minimal</p> | <p><b>Remarks</b><br/>Trunk Hood, Rear Gate - Scratch &amp; Dent - Small / Rear Bumper, Lamps, Panels - Scratch - Medium / (R) Rear Fender, Molding - Scratch - Small / (R) Rear Door, Molding - Scratch &amp; Dent - Medium / (R) Front Door, Molding - Scratch &amp; Dent - Small / (R) Step, In-panel, Side Spoiler - Scratch &amp; Dent - Large / Roof - Scratch &amp; Dent - Small / (R) Front Fender, Molding - Scratch &amp; Dent - Small / Bonnet, Headlight - Scratch &amp; Dent - Minimal / Front Bumper, Grille, Lamps - Scratch - Medium / (L) Front Fender, Molding - Modified - Small / (L) Rear Door, Molding - Scratch &amp; Dent - Minimal / (L) Front Door, Molding - Scratch &amp; Dent - Minimal / (L) Step, In-panel, Side Spoiler - Scratch - Minimal / (L) Rear Fender, Molding - Scratch &amp; Dent - Minimal</p> |

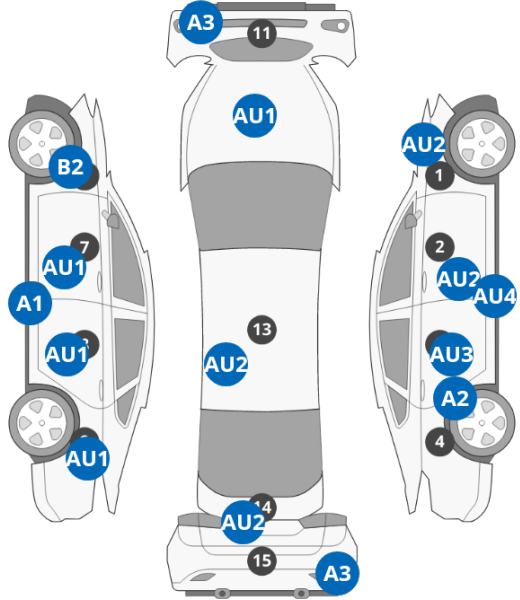
| Inspector Notes |
|---|
| <p>with LTO plate, with spare tire, with reverse camera, with manual and warranty booklet, with inc tools, no jack, no spare key, scratches and dent on exterior, scratches in taillight and headlight.</p> |
