## General Information

| Make | Toyota | Model | Avanza |
| YOM | 2024 | Odo Meter Reading | 78,383 |
| Registration No. | NHM8256 | Chassis No. | MHFAA1BY9R0023174 |

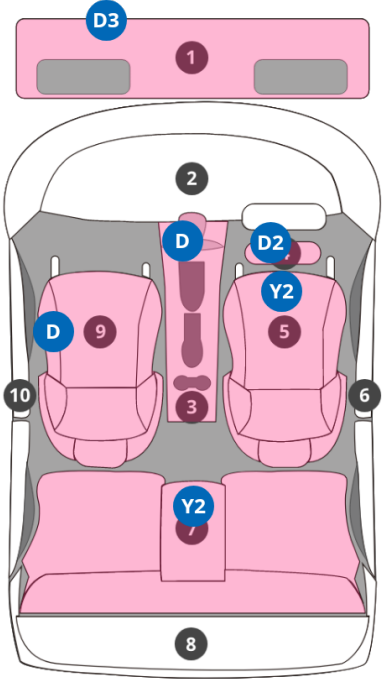
| Interior Evaluation : <b>B</b> | Exterior Evaluation : <b>E</b> |
|---|---|
| <p><b>Remarks</b><br/>Console, Switchs, Vents - Traces of Adhesive Tape - Yes / (L) Front Seat - Worn - Yes / (R) Front Seat - Grime - Small / (L) Front Floor Mat - Worked - Small / Ceiling - Crinkle - Medium / Rear Seat - Grime - Small</p> | <p><b>Remarks</b><br/>(R) Front Door, Molding - Repair mark - Yes / (R) Rear Door, Molding - Repair mark - Yes / (R) Front Fender, Molding - Scratch - Minimal / (R) Mirror - Scratch - Small / (R) Step, In-panel, Side Spoiler - Repair mark - Yes / (R) Step, In-panel, Side Spoiler - Dent - Small / (R) Rear Fender, Molding - Scratch - Small / (R) Front Door, Molding - Scratch - Minimal / (R) Rear Door, Molding - Scratch - Minimal / Rear Bumper, Lamps, Panels - Crack, Gap - Large / Trunk Hood, Rear Gate - Scratch &amp; Dent - Small / (L) Rear Fender, Molding - Scratch &amp; Dent - Medium / (L) Rear Door, Molding - Scratch - Large / (L) Front Door, Molding - Scratch - Small / (L) Front Fender, Molding - Scratch - Small / (L) Mirror - Scratch - Small / Front Bumper, Grille, Lamps - Scratch &amp; Dent - Medium / Bonnet, Headlight - Scratch - Small / Roof - Scratch - Small</p> |

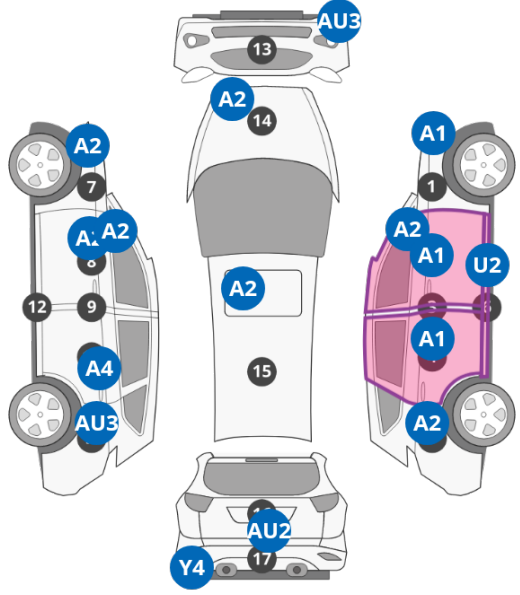
no warranty booklet, with jack, incomplete tools, with spare tire, with LTO plate, scratches on tail light, plate light issue
