## General Information

| Make | Toyota | Model | Vios |
| YOM | 2025 | Odo Meter Reading | 17,803 |
| Registration No. | NJF6383 | Chassis No. | PA1B18F32S4284608 |

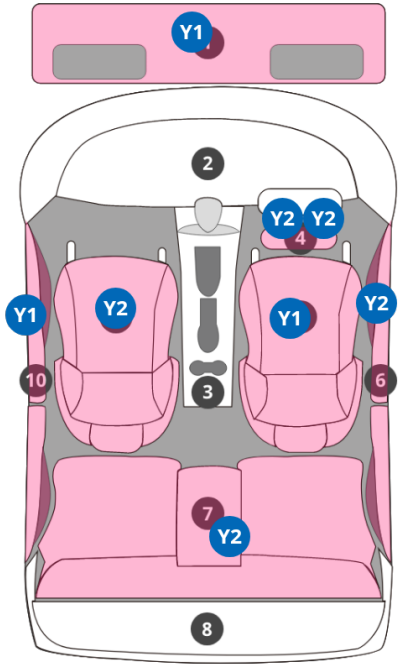
| Interior Evaluation : <b>B</b> | Exterior Evaluation : <b>D</b> |
|---|---|
| <p><b>Remarks</b><br/>(L) Front Seat - Grime - Small / (R) Front Seat - Grime - Minimal / Rear Seat - Grime - Small / (L) Front Floor Mat - Grime - Small / (R) Front Floor Mat - Grime - Small / (R) Front Trim - Grime - Small / (L) Front Trim - Grime - Minimal / Ceiling - Grime - Minimal</p> | <p><b>Remarks</b><br/>(R) Front Fender - Repair Traces - Yes / Bonnet - Repair Traces - Yes / (L) Front Fender - Repair Traces - Yes / (R) Rear Door, Molding - Scratch - Medium / (R) Front Door, Molding - Scratch - Medium / (R) Front Fender, Molding - Scratch &amp; Dent - Minimal / (R) Step, In-panel, Side Spoiler - Scratch &amp; Dent - Minimal / Front Bumper, Grille, Lamps - Scratch - Small / Bonnet, Headlight - Scratch - Medium / (L) Front Fender, Molding - Scratch - Medium / (L) Front Door, Molding - Scratch - Medium / (L) Step, In-panel, Side Spoiler - Scratch &amp; Dent - Small / (L) Rear Fender, Molding - Dent - Small / (L) Rear Door, Molding - Scratch &amp; Dent - Minimal / Trunk Hood, Rear Gate - Scratch - Small / (R) Rear Fender, Molding - Scratch - Small / Rear Bumper, Lamps, Panels - Scratch - Small / Roof - Dent - Small</p> |

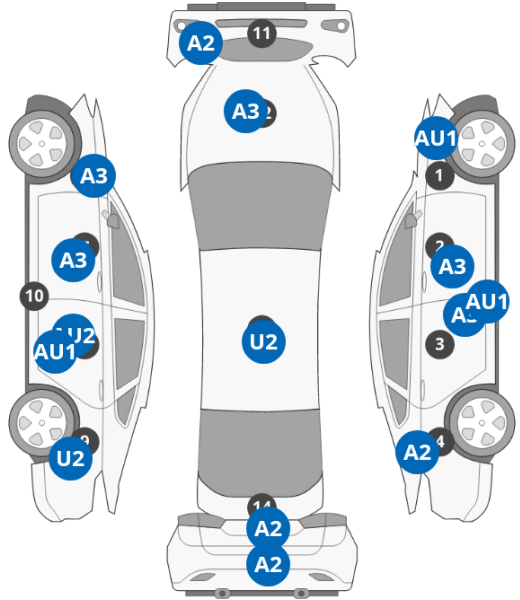
| Inspector Notes |
|---|
| <p>with LTO plate, with warranty and manual booklet, with spare tire and key, with jack and inc tools, with reverse camera, scratches and dent on exterior, scratches on taillight and headlight.</p> |
