## General Information

| Make | Toyota | Model | Hilux Tamaraw |

## Body / Panel Condition

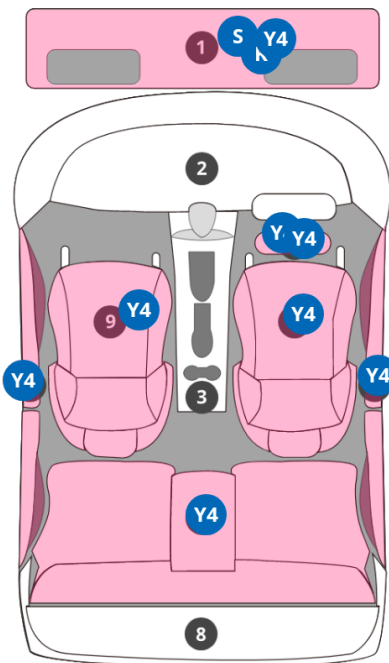
| Interior Evaluation :<br>E | Exterior Evaluation :<br>D |
| <p><b>Remarks</b></p> <p>Overall Interior - Smell - Yes / Overall Interior - Animal Hair - Yes / Ceiling - Grime - Large / Rear Seat - Grime - Large / (R) Front Floor Mat - Grime - Large / (L) Front Floor Mat - Grime - Large / (L) Front Seat - Grime - Large / (R) Front Seat - Grime - Large / (L) Front Trim - Grime - Large / (R) Front Trim - Grime - Large</p> | <p><b>Remarks</b></p> <p>(R) Front Door - Repair Traces - Yes / Roof - Repair Traces - Yes / (L) Front Fender, Molding - Scratch - Small / Bonnet, Headlight - Scratch - Large / Front Bumper, Grille, Lamps - Crack, Gap - Small / (R) Front Fender, Molding - Scratch - Small / (R) Front Door, Molding - Scratch - Small / (R) Side Gate - Scratch - Large / (R) Step, In-panel, Side Spoiler - Scratch - Small / Rear Bumper, Lamps, Panels - Scratch - Small / Rear Gate - Scratch - Small / (L) Side Gate - Scratch - Medium / (L) Front Door, Molding - Scratch - Small / (L) Mirror - Scratch - Small / (L) Step, In-panel, Side Spoiler - Scratch - Small</p> |
