## General Information

| Make | Toyota | Model | Raize |

## Body / Panel Condition

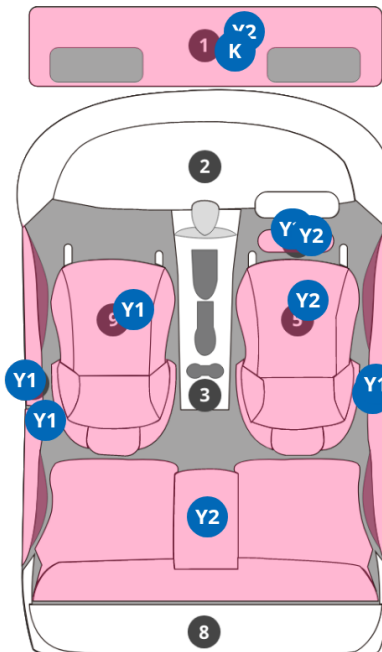
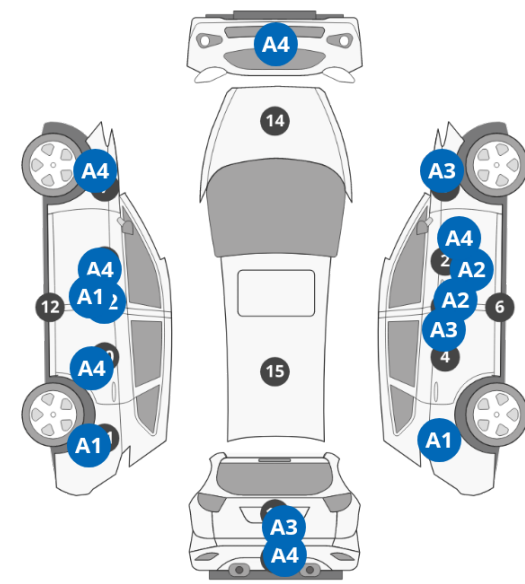
| Interior Evaluation : <b>B</b> | Exterior Evaluation : <b>E</b> |
| <b>Remarks</b><br>(R) Front Trim - Grime - Minimal / (R) Front Floor Mat - Grime - Small / (L) Front Floor Mat - Grime - Small / Mat Other - Grime - Small / Ceiling - Grime - Small / Overall Interior - Animal Hair - Yes / (R) Front Seat - Grime - Small / (L) Front Seat - Grime - Minimal / Rear Seat - Grime - Small / (R) Rear Trim - Grime - Minimal / (L) Rear Trim - Grime - Minimal / (L) Front Trim - Grime - Minimal | <b>Remarks</b><br>(L) Front Fender, Molding - Scratch - Large / Front Bumper, Grille, Lamps - Scratch - Large / (R) Front Fender, Molding - Scratch - Medium / (R) Mirror - Scratch - Small / (R) Front Door, Molding - Scratch - Large / (R) Step, In-panel, Side Spoiler - Scratch - Small / (R) Rear Door, Molding - Scratch - Medium / Rear Bumper, Lamps, Panels - Scratch - Large / Trunk Hood, Rear Gate - Scratch - Medium / (R) Rear Fender, Molding - Scratch - Minimal / (L) Rear Fender, Molding - Scratch - Minimal / (L) Rear Door, Molding - Scratch - Large / (L) Front Door, Molding - Scratch - Large / (L) Step, In-panel, Side Spoiler - Scratch - Small / (L) Mirror - Scratch - Minimal |
