## General Information

| Make | Toyota | Model | Vios |
| YOM | 2024 | Mileage | 28,143 |

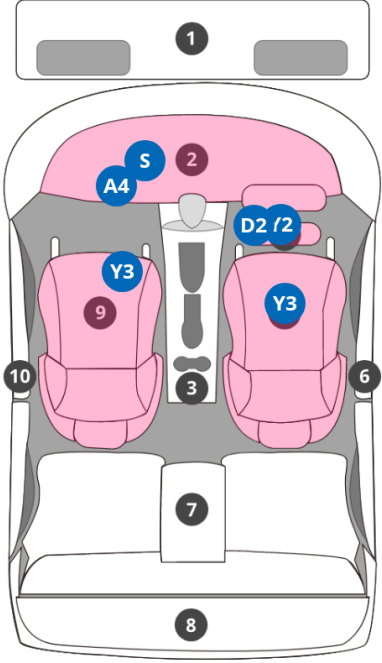
| Interior Evaluation : <span style="color: red;">C</span> | Exterior Evaluation : <span style="color: red;">C</span> |
| <b>Remarks</b><br>(R) Front Seat - Grime - Medium / Mat Other - Grime - Small / (L) Front Seat - Grime - Medium / (L) Front Floor Mat - Worked - Small / Overall Interior - Smell - Yes / Steering Wheel - Worn, Peel, Crack - Large | <b>Remarks</b><br>(R) Front Fender - Repair Traces - Yes / Roof - Repair Traces - Yes / Member (Bolted) - Dent - Yes / Front Bumper, Grille, Lamps - Scratch - Large / (L) Front Door, Molding - Scratch - Small / (L) Rear Door, Molding - Scratch - Small / (L) Rear Fender, Molding - Scratch - Small / (R) Rear Fender, Molding - Dent - Small / (R) Front Fender, Molding - Dent - Medium |
