## General Information

| Make | Toyota | Model | Wigo |
| YOM | 2025 | Odo Meter Reading | 10,844 |
| Registration No. | GBB3019 | Chassis No. | MHKAA1BC8SJ044748 |

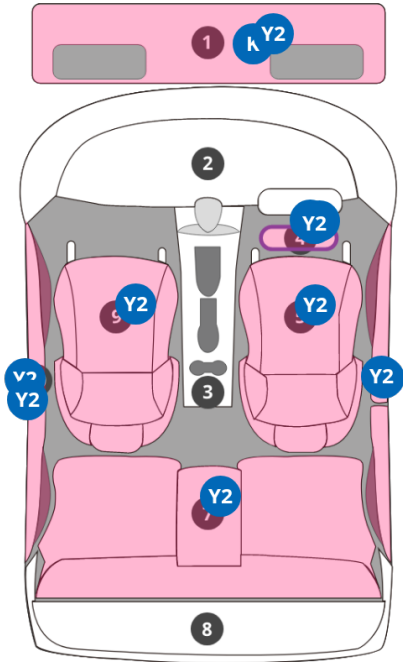
| Interior Evaluation : <b>B</b> | Exterior Evaluation : <b>E</b> |
|---|---|
| <b>Remarks</b><br>Rear Seat - Grime - Small / (R) Rear Trim - Grime - Small / (R) Front Trim - Grime - Small / (R) Front Floor Mat - Missing - Yes / (L) Front Floor Mat - Missing - Yes / Mat Other - Grime - Small / (R) Front Seat - Grime - Small / (L) Front Seat - Grime - Small / (L) Rear Trim - Grime - Small / (L) Front Trim - Grime - Small / Overall Interior - Animal Hair - Yes / Ceiling - Grime - Small | <b>Remarks</b><br>Front Bumper, Grille, Lamps - Scratch & Dent - Large / Bonnet, Headlight - Scratch - Medium / (R) Front Fender, Molding - Scratch - Small / (R) Mirror - Scratch - Medium / (R) Step, In-panel, Side Spoiler - Scratch - Medium / (R) Rear Door, Molding - Scratch - Large / (R) Front Door, Molding - Scratch - Large / (R) Rear Fender, Molding - Scratch - Medium / Rear Bumper, Lamps, Panels - Scratch - Medium / Trunk Hood, Rear Gate - Scratch - Small / (L) Rear Fender, Molding - Scratch - Small / (L) Rear Door, Molding - Scratch & Dent - Large / (L) Step, In-panel, Side Spoiler - Scratch - Small / (L) Mirror - Scratch - Minimal / (L) Front Door, Molding - Scratch - Small |

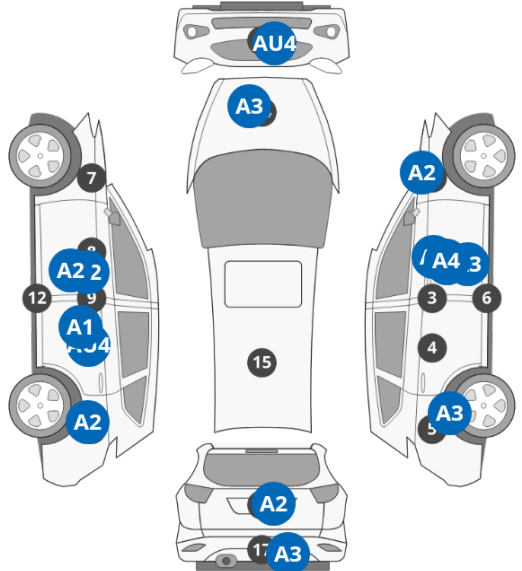
Incomplete tools. Gap at front bumper. Visible hairline scratches. adhesive water marks at exterior. Right side side mirror temporary. Without LTO Plate. With warranty booklet, seatcover, sparetire, jack and 1key.
