## General Information

| Make | Toyota | Model | Wigo |

## Body / Panel Condition

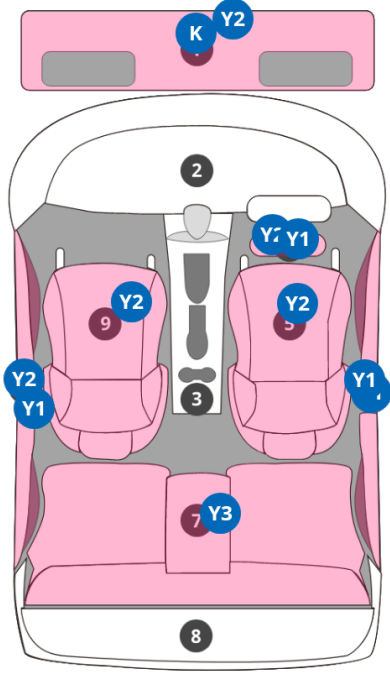
| Interior Evaluation : <b>B</b> | Exterior Evaluation : <b>E</b> |
|---|---|
| <p><b>a</b> : Cut, Fray <b>d</b> : Loose, Deformed <b>k</b> : Animal Hair <b>s</b> : Smell <b>t</b> : Cigarette Burns <b>x</b> : Defective <b>y</b> : Stain</p> | <p><b>A</b> : Scratch <b>AU</b> : Scratch &amp; Dent <b>B</b> : Modified <b>C</b> : Corrosion <b>G</b> : Stone chip <b>P</b> : Faded <b>S</b> : Rust <b>SC</b> : Rust &amp; Corrosion <b>U</b> : Dent <b>X</b> : Defective <b>Y</b> : Crack, Gap</p> |
| <p><b>Remarks</b></p> <p>Overall Interior - Animal Hair - Yes / Mat Other - Grime - Small / (R) Rear Trim - Grime - Minimal / (R) Front Seat - Grime - Small / (R) Front Floor Mat - Grime - Minimal / (R) Front Trim - Grime - Minimal / Rear Seat - Grime - Medium / (L) Rear Trim - Grime - Minimal / (L) Front Trim - Grime - Small / (L) Front Seat - Grime - Small / Ceiling - Grime - Small</p> | <p><b>Remarks</b></p> <p>Front Bumper, Grille, Lamps - Scratch - Large / (L) Front Fender, Molding - Scratch - Small / Bonnet, Headlight - Scratch - Small / (R) Front Fender, Molding - Scratch - Small / (R) Front Door, Molding - Scratch &amp; Dent - Medium / (R) Mirror - Scratch - Medium / (R) Step, In-panel, Side Spoiler - Scratch - Small / (R) Rear Door, Molding - Scratch - Medium / (R) Rear Fender, Molding - Scratch - Large / Rear Bumper, Lamps, Panels - Scratch - Large / Trunk Hood, Rear Gate - Scratch - Small / (L) Rear Fender, Molding - Scratch - Small / (L) Rear Door, Molding - Scratch - Medium / (L) Step, In-panel, Side Spoiler - Scratch - Small / (L) Mirror - Scratch - Medium / (L) Front Door, Molding - Scratch - Small</p> |

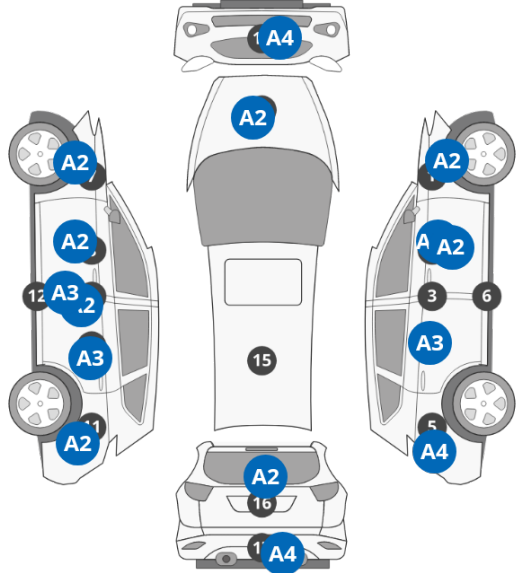
| Inspector Notes |
|---|
| <p>Incomplete tools. Rear right side taillight crack. With warranty booklet, seatcover, sparetire , jack, LTO PLate and 1key.</p> |
