## General Information

| Make | Toyota | Model | Avanza |

## Body / Panel Condition

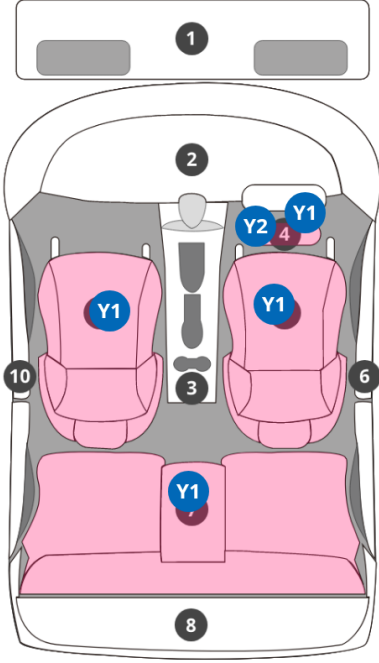
| Interior Evaluation : <b>A</b> | Exterior Evaluation : <b>B</b> |
|---|---|
| <b>Remarks</b><br>(R) Front Seat - Grime - Minimal / (L) Front Seat - Grime - Minimal / Rear Seat - Grime - Minimal / (R) Front Floor Mat - Grime - Minimal / (L) Front Floor Mat - Grime - Small | <b>Remarks</b><br>(R) Front Fender, Molding - Scratch - Minimal / (R) Front Door, Molding - Scratch - Minimal / (R) Rear Door, Molding - Scratch & Dent - Small / (R) Step, In-panel, Side Spoiler - Scratch - Small / (R) Rear Fender, Molding - Scratch - Minimal / Rear Bumper, Lamps, Panels - Scratch - Minimal / Trunk Hood, Rear Gate - Scratch - Minimal / (L) Rear Fender, Molding - Dent - Minimal / (L) Rear Door, Molding - Scratch - Minimal / (L) Step, In-panel, Side Spoiler - Scratch - Small / (L) Front Door, Molding - Scratch - Small / (L) Front Fender, Molding - Scratch - Small / Front Bumper, Grille, Lamps - Scratch - Small / Bonnet, Headlight - Scratch - Minimal / Roof - Scratch - Minimal |

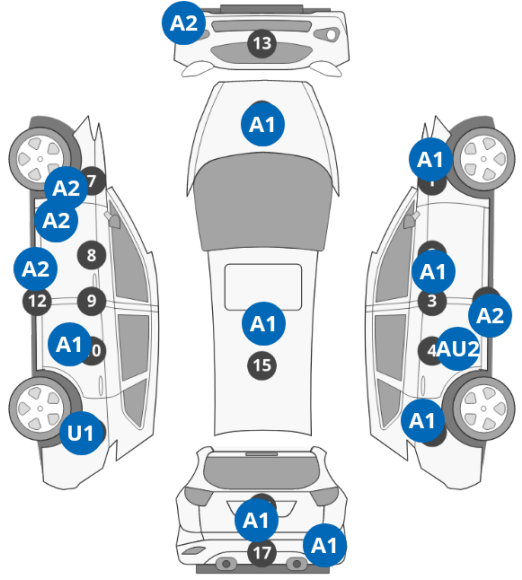
no LTO plate/with warranty booklet/with tools and jack/with spare tire/with spare key/with seat cover/minimal scratches on taillight cover/hairline scratches on the body
