## General Information

| Make | Toyota | Model | Avanza |

## Body / Panel Condition

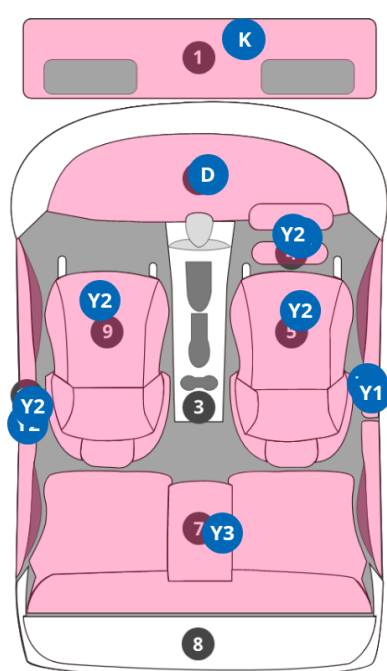
| <div> <div>Interior Evaluation :</div> <div>C</div> </div> | <div> <div>Exterior Evaluation :</div> <div>E</div> </div> |
| <div> <div>Remarks</div> <div>(R) Front Floor Mat - Grime - Minimal / (L) Front Floor Mat - Grime - Small / Mat Other - Grime - Small / Dashboard - Traces of Adhesive Tape - Yes / Ceiling - Grime - Minimal / Overall Interior - Animal Hair - Yes / (R) Front Seat - Grime - Small / (L) Front Seat - Grime - Small / (R) Front Trim - Grime - Minimal / (R) Rear Trim - Grime - Minimal / Rear Seat - Grime - Medium / (L) Rear Trim - Grime - Small / (L) Front Trim - Grime - Small</div> </div> | <div> <div>Remarks</div> <div>(L) Front Fender, Molding - Scratch - Small / Bonnet, Headlight - Scratch - Small / Front Bumper, Grille, Lamps - Scratch - Large / (R) Front Fender, Molding - Scratch - Medium / (R) Mirror - Scratch - Medium / (R) Front Door, Molding - Scratch - Large / (R) Step, In-panel, Side Spoiler - Scratch - Small / (R) Rear Door, Molding - Scratch - Large / (R) Rear Fender, Molding - Scratch - Large / Rear Bumper, Lamps, Panels - Dent - Medium / Trunk Hood, Rear Gate - Scratch &amp; Dent - Large / (L) Rear Fender, Molding - Scratch - Small / (L) Rear Door, Molding - Scratch - Small / (L) Step, In-panel, Side Spoiler - Scratch - Small / (L) Front Door, Molding - Scratch - Small / (L) Mirror - Scratch - Minimal</div> </div> |

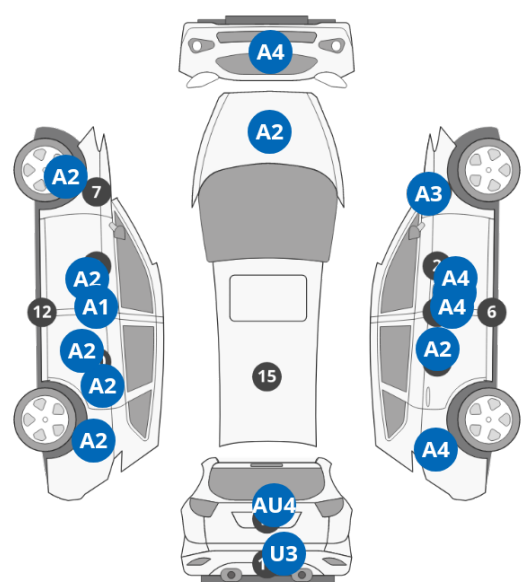
Rear trunk door cannot be open. Visible hairline scratches. Without warranty booklet, jack, tools, seatcover. With spare tire, LTO plate and 2 keys.
