## General Information

| Make | Toyota | Model | Vios |

## Body / Panel Condition

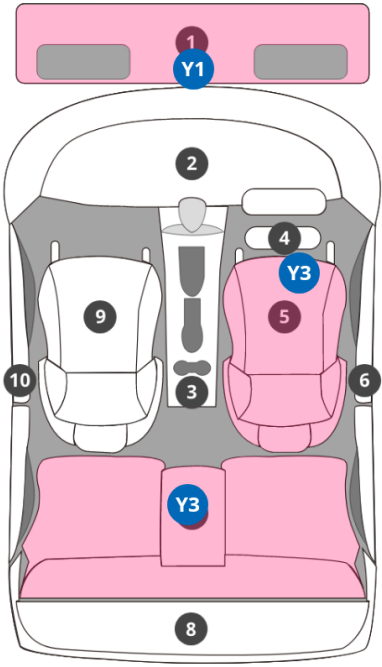
| <b>Interior Evaluation :</b> <b>B</b> | <b>Exterior Evaluation :</b> <b>E</b> |
| <b>Remarks</b><br>(R) Front Seat - Grime - Medium / Rear Seat - Grime - Medium / Ceiling - Grime - Minimal | <b>Remarks</b><br>Front Windshield - Damaged - Large / (L) Front Fender, Molding - Scratch & Dent - Large / (L) Front Door, Molding - Scratch & Dent - Large / (L) Step, In-panel, Side Spoiler - Scratch & Dent - Medium / (R) Front Door, Molding - Scratch & Dent - Small / (R) Front Fender, Molding - Scratch & Dent - Medium / (R) Step, In-panel, Side Spoiler - Scratch & Dent - Medium / (R) Rear Fender, Molding - Scratch & Dent - Small / Rear Bumper, Lamps, Panels - Scratch & Dent - Medium / Roof - Dent - Small / Front Bumper, Grille, Lamps - Scratch - Medium / Bonnet, Headlight - Dent - Small / (L) Mirror - Scratch - Minimal |
