## General Information

| Make | Toyota | Model | Avanza |
| YOM | 2024 | Odo Meter Reading | 40,188 |

## Body / Panel Condition

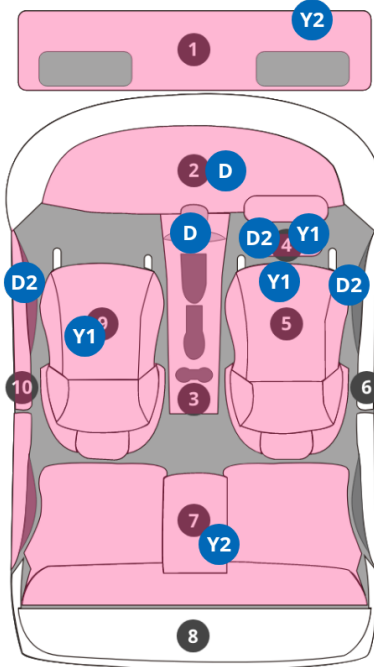
| <div> <div>Interior Evaluation :</div> <div>B</div> </div> | <div> <div>Exterior Evaluation :</div> <div>C</div> </div> |
| <div> <div>Remarks</div> <div>Dashboard - Traces of Adhesive Tape - Yes / (R) Front Seat - Grime - Minimal / (L) Front Seat - Grime - Minimal / (L) Front Floor Mat - Worked - Small / (R) Front Floor Mat - Grime - Minimal / Rear Seat - Grime - Small / Ceiling - Grime - Small / (L) Front Trim - Worked - Small / (R) Front Seat Head Rest - Worked - Small / Console, Switches, Vents - Traces of Adhesive Tape - Yes</div> </div> | <div> <div>Remarks</div> <div>(R) Front Fender, Molding - Scratch - Minimal / (R) Front Door, Molding - Scratch - Small / (R) Rear Door, Molding - Scratch - Small / (R) Rear Fender, Molding - Dent - Medium / Rear Bumper, Lamps, Panels - Scratch - Minimal / Trunk Hood, Rear Gate - Scratch &amp; Dent - Small / (L) Rear Fender, Molding - Scratch &amp; Dent - Minimal / (L) Rear Door, Molding - Scratch - Minimal / (L) Front Door, Molding - Scratch - Large / (L) Mirror - Scratch - Minimal / (R) Mirror - Scratch - Minimal / (L) Step, In-panel, Side Spoiler - Scratch - Minimal / (R) Step, In-panel, Side Spoiler - Scratch - Minimal / (L) Front Fender, Molding - Scratch - Small / Front Bumper, Grille, Lamps - Scratch - Medium / Bonnet, Headlight - Scratch - Minimal / Roof - Scratch - Minimal</div> </div> |
