## General Information

| Make | Toyota | Model | Vios |

## Body / Panel Condition

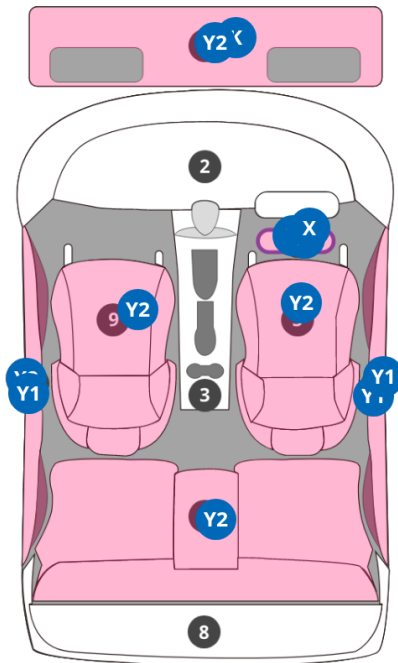
| Interior Evaluation : <b>B</b> | Exterior Evaluation : <b>E</b> |
|---|---|
| <b>Remarks</b><br>(R) Front Floor Mat - Missing - Yes / (L) Front Floor Mat - Missing - Yes / Mat Other - Missing - Yes / (R) Front Seat - Grime - Small / (L) Front Trim - Grime - Small / (L) Rear Trim - Grime - Minimal / (R) Rear Trim - Grime - Minimal / (R) Front Trim - Grime - Minimal / Overall Interior - Animal Hair - Yes / Ceiling - Grime - Small / (L) Front Seat - Grime - Small / Rear Seat - Grime - Small | <b>Remarks</b><br>(R) Front Fender, Molding - Scratch - Minimal / (R) Mirror - Scratch - Small / (R) Front Door, Molding - Scratch - Large / (R) Side Window - Scratch, Stone chip - Small / (R) Step, In-panel, Side Spoiler - Scratch - Minimal / (R) Rear Door, Molding - Scratch & Dent - Large / (R) Rear Fender, Molding - Scratch - Small / Rear Bumper, Lamps, Panels - Scratch - Small / Trunk Hood, Rear Gate - Dent - Medium / (L) Rear Fender, Molding - Scratch - Medium / (L) Rear Door, Molding - Scratch - Medium / (L) Step, In-panel, Side Spoiler - Scratch & Dent - Large / (L) Front Door, Molding - Scratch - Medium / (L) Mirror - Scratch - Small / (L) Front Fender, Molding - Scratch - Medium / Bonnet, Headlight - Dent - Medium / Front Bumper, Grille, Lamps - Crack, Gap - Large |

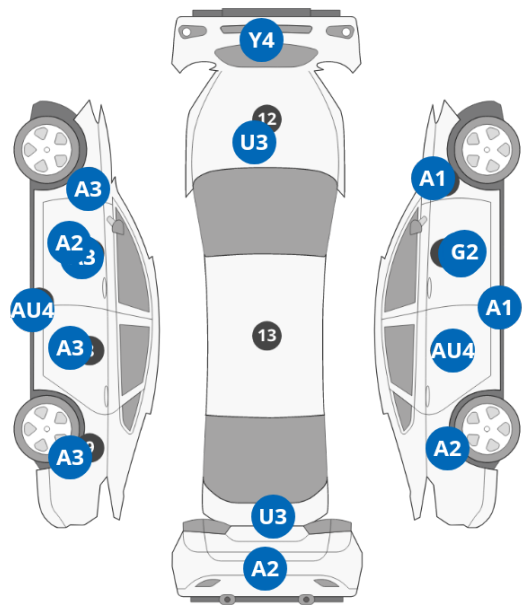
| Inspector Notes |
|---|
| Possible flooded. Large gap at front bumper. Right side headlight crack. Rear both Taillight crack. Incomplete tools. With warranty booklet, seatcover, jack, sparetire, LTO plate and 3keys. |
