## General Information

| Make | Toyota | Model | Avanza |

## Body / Panel Condition

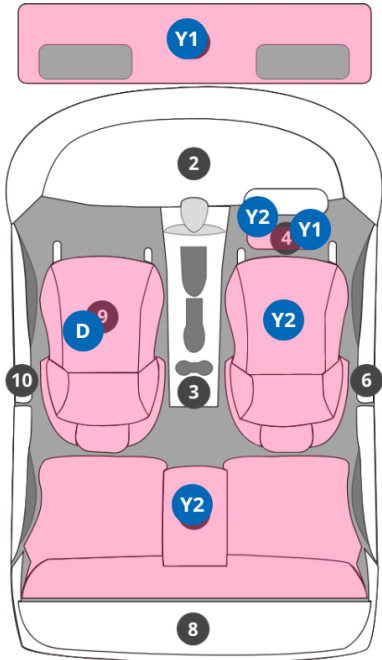
| <div> <div>Interior Evaluation :</div> <div>B</div> </div> | <div> <div>Exterior Evaluation :</div> <div>C</div> </div> |
| <div> <div>Remarks</div> <div>Rear Seat - Grime - Small / (R) Front Seat - Grime - Small / (L) Front Seat - Worn - Yes / Ceiling - Grime - Minimal / (R) Front Floor Mat - Grime - Minimal / (L) Front Floor Mat - Grime - Small</div> </div> | <div> <div>Remarks</div> <div>(L) Front Fender, Molding - Scratch - Minimal / (L) Mirror - Scratch - Minimal / (L) Front Door, Molding - Scratch - Minimal / (L) Step, In-panel, Side Spoiler - Scratch - Small / (L) Rear Door, Molding - Scratch - Minimal / (L) Rear Fender, Molding - Scratch &amp; Dent - Medium / Trunk Hood, Rear Gate - Scratch &amp; Dent - Minimal / Rear Bumper, Lamps, Panels - Scratch - Small / (R) Rear Fender, Molding - Scratch - Small / (R) Rear Door, Molding - Scratch - Small / (R) Step, In-panel, Side Spoiler - Scratch - Small / (R) Front Door, Molding - Scratch - Small / (R) Mirror - Scratch - Minimal / (R) Front Fender, Molding - Scratch - Small / Front Bumper, Grille, Lamps - Scratch - Medium / Bonnet, Headlight - Scratch - Minimal / Roof - Scratch - Small</div> </div> |

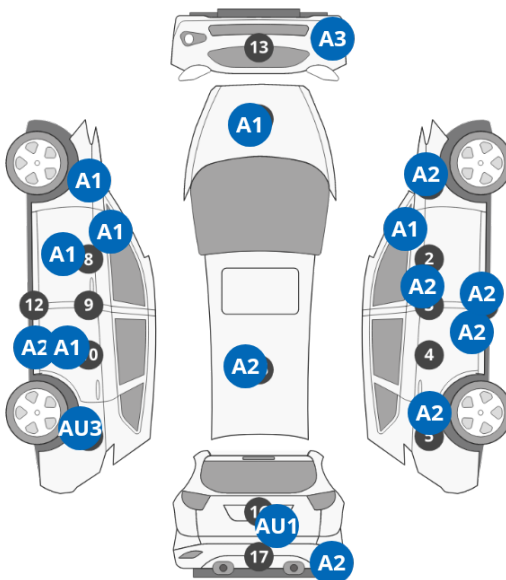
with LTO plate/with warranty booklet/with incomplete tools with jack/with spare tire/no spare key/scratches on headlight cover/with seat cover/hairline scratches on the body
