## General Information

| Make | Toyota | Model | Vios |
| YOM | 2024 | Odo Meter Reading | 35,631 |
| Registration No. | GBE6403 | Chassis No. | PA1B18F33P4238325 |

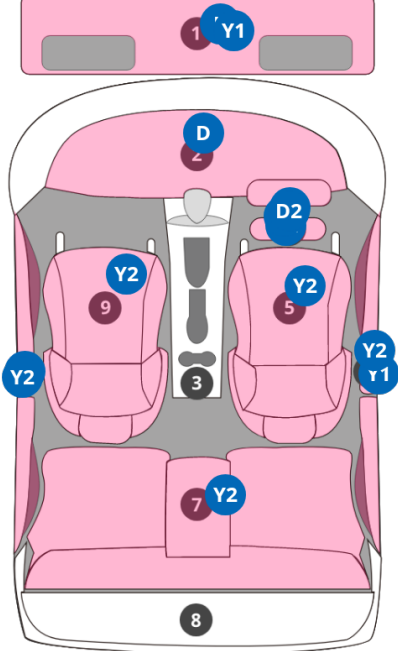
| Interior Evaluation : <b>C</b> | Exterior Evaluation : <b>E</b> |
| <p><b>a</b> : Cut, Fray <b>d</b> : Loose, Deformed <b>k</b> : Animal Hair <b>s</b> : Smell <b>t</b> : Cigarette Burns <b>x</b> : Defective <b>y</b> : Stain</p> | <p><b>A</b> : Scratch <b>AU</b> : Scratch &amp; Dent <b>B</b> : Modified <b>C</b> : Corrosion <b>G</b> : Stone chip <b>P</b> : Faded <b>S</b> : Rust <b>SC</b> : Rust &amp; Corrosion <b>U</b> : Dent <b>X</b> : Defective <b>Y</b> : Crack, Gap</p> |
| <p><b>Remarks</b></p> <p>Overall Interior - Animal Hair - Yes / Mat Other - Grime - Small / Rear Seat - Grime - Small / (L) Rear Trim - Grime - Minimal / (L) Front Trim - Grime - Small / (R) Rear Trim - Grime - Minimal / (R) Front Floor Mat - Grime - Small / (R) Front Trim - Grime - Small / (R) Front Seat - Grime - Small / (L) Front Seat - Grime - Small / (L) Front Floor Mat - Grime - Small / (L) Front Floor Mat - Worked - Small / Dashboard - Traces of Adhesive Tape - Yes / Ceiling - Grime - Minimal</p> | <p><b>Remarks</b></p> <p>(R) Rear Fender - Repair Traces - Yes / (L) Mirror - Scratch - Minimal / (L) Front Fender, Molding - Scratch - Small / Bonnet, Headlight - Scratch - Small / Front Bumper, Grille, Lamps - Scratch - Medium / (R) Front Fender, Molding - Scratch - Minimal / (R) Mirror - Scratch - Minimal / (R) Front Door, Molding - Scratch - Medium / (R) Step, In-panel, Side Spoiler - Scratch - Small / (R) Rear Door, Molding - Scratch &amp; Dent - Medium / (R) Rear Fender, Molding - Scratch &amp; Dent - Large / Rear Bumper, Lamps, Panels - Scratch - Large / Trunk Hood, Rear Gate - Scratch - Small / (L) Rear Fender, Molding - Scratch - Small / (L) Rear Door, Molding - Scratch - Small / (L) Step, In-panel, Side Spoiler - Scratch - Small / (L) Front Door, Molding - Scratch - Small</p> |
