## General Information

| Make | Toyota | Model | Wigo |

## Body / Panel Condition

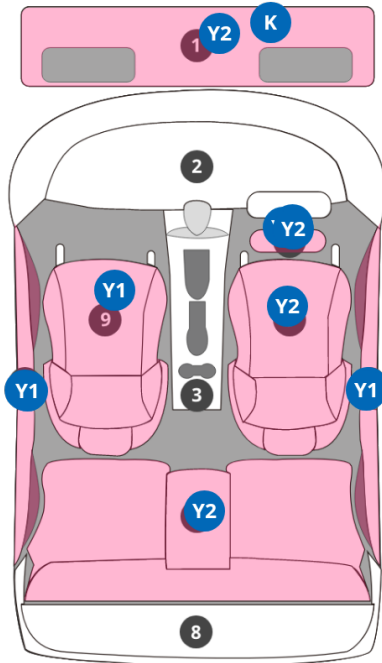
| Interior Evaluation : <b>B</b> | Exterior Evaluation : <b>E</b> |
| <p><b>Remarks</b><br/> Mat Other - Grime - Minimal / Rear Seat - Grime - Small / (R) Rear Trim - Grime - Minimal / (R) Front Trim - Grime - Minimal / (R) Front Seat - Grime - Small / (R) Front Floor Mat - Grime - Minimal / (L) Front Seat - Grime - Minimal / (L) Rear Trim - Grime - Minimal / (L) Front Trim - Grime - Minimal / Ceiling - Grime - Small / Overall Interior - Animal Hair - Yes / (L) Front Floor Mat - Grime - Small</p> | <p><b>Remarks</b><br/> Front Bumper, Grille, Lamps - Scratch - Medium / Bonnet, Headlight - Scratch - Minimal / (R) Mirror - Scratch - Minimal / (R) Front Fender, Molding - Scratch - Small / (R) Step, In-panel, Side Spoiler - Scratch - Small / (R) Front Door, Molding - Scratch - Medium / (R) Rear Door, Molding - Scratch &amp; Dent - Large / (R) Rear Fender, Molding - Scratch &amp; Dent - Medium / Rear Bumper, Lamps, Panels - Scratch - Large / Trunk Hood, Rear Gate - Scratch - Minimal / (L) Rear Fender, Molding - Scratch - Small / (L) Rear Door, Molding - Scratch - Medium / (L) Front Door, Molding - Scratch - Small / (L) Step, In-panel, Side Spoiler - Scratch - Minimal</p> |
