## General Information

| Make | Toyota | Model | Vios |
| Registration No. | VAC2176 | Chassis No. | PA1B18F38R4249601 |

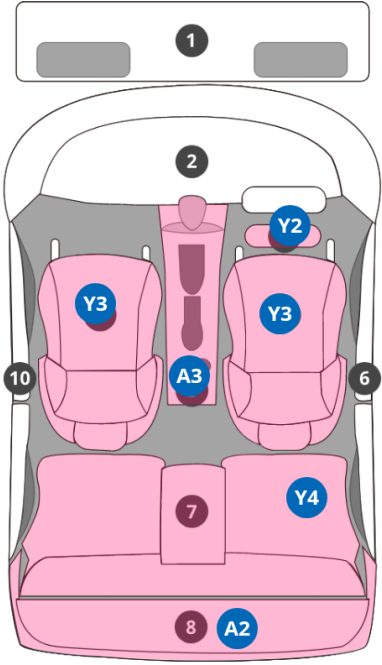
| Interior Evaluation : <span>C</span> | Exterior Evaluation : <span>C</span> |
| <b>Remarks</b><br>(L) Front Floor Mat - Grime - Small / (L) Front Seat - Grime - Medium / (R) Front Seat - Grime - Medium / Rear Seat - Grime - Large / Knobs - Worn, Peel, Crack - Medium / Trunk Room - Worn, Scratch, Cut, Crack - Small | <b>Remarks</b><br>Front Bumper, Grille, Lamps - Scratch - Large / (L) Front Fender, Molding - Scratch & Dent - Medium / (L) Rear Fender, Molding - Dent - Small / (L) Rear Door, Molding - Scratch - Small / Rear Bumper, Lamps, Panels - Scratch - Medium / (R) Rear Fender, Molding - Dent - Small / (R) Front Door, Molding - Dent - Minimal / (R) Rear Door, Molding - Scratch - Minimal / Trunk Hood, Rear Gate - Scratch - Minimal |
