## General Information

| Make | Toyota | Model | Avanza |
| Registration No. | NJC7173 | Chassis No. | MHFAB1BY3S3143179 |

## Overall Evaluation :

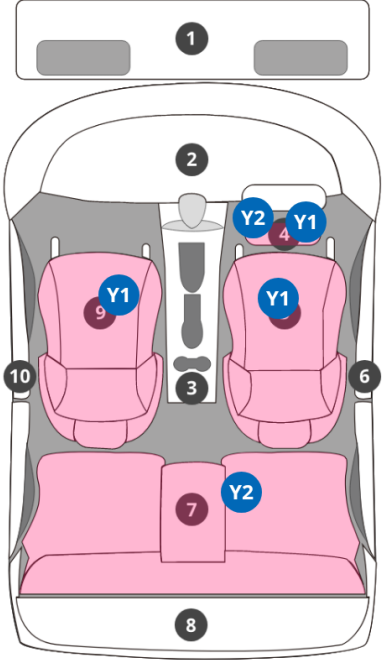
| Interior Evaluation : <b>A</b> | Exterior Evaluation : <b>C</b> |
|---|---|
| <p><b>Remarks</b><br/>Rear Seat - Grime - Small / (R) Front Seat - Grime - Minimal / (L) Front Seat - Grime - Minimal / (R) Front Floor Mat - Grime - Minimal / (L) Front Floor Mat - Grime - Small</p> | <p><b>Remarks</b><br/>(L) Rear Fender, Molding - Scratch - Minimal / (R) Rear Fender, Molding - Dent - Minimal / (L) Front Door, Molding - Scratch - Small / (L) Rear Door, Molding - Scratch - Minimal / (L) Step, In-panel, Side Spoiler - Scratch - Minimal / (L) Mirror - Scratch - Minimal / (L) Front Fender, Molding - Scratch - Minimal / Bonnet, Headlight - Scratch - Small / Front Bumper, Grille, Lamps - Scratch &amp; Dent - Medium / (R) Front Fender, Molding - Scratch - Small / (R) Front Door, Molding - Scratch - Minimal / (R) Rear Door, Molding - Scratch - Small / (R) Step, In-panel, Side Spoiler - Scratch - Minimal / Roof - Scratch - Small</p> |
