## General Information

| Make | Toyota | Model | Vios |

## Body / Panel Condition

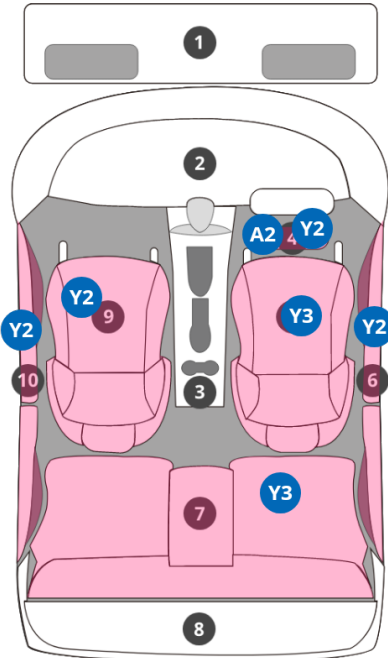
| <div> <div>Interior Evaluation :</div> <div>B</div> </div> | <div> <div>Exterior Evaluation :</div> <div>D</div> </div> |
| <div> <div>Remarks</div> <p> Rear Seat - Grime - Medium / (R) Front Trim - Grime - Small / (R) Front Seat - Grime - Medium / (R) Front Floor Mat - Grime - Small / (L) Front Trim - Grime - Small / (L) Front Floor Mat - Cut, Crack - Small / (L) Front Seat - Grime - Small </p> </div> | <div> <div>Remarks</div> <p> (L) Front Fender, Molding - Scratch - Small / (L) Mirror - Scratch - Minimal / (L) Front Door, Molding - Scratch - Small / (L) Step, In-panel, Side Spoiler - Scratch - Small / (L) Rear Door, Molding - Scratch - Small / (L) Rear Fender, Molding - Scratch - Minimal / Trunk Hood, Rear Gate - Scratch - Small / Rear Bumper, Lamps, Panels - Scratch - Small / (R) Rear Fender, Molding - Scratch - Small / (R) Rear Door, Molding - Scratch - Small / (R) Step, In-panel, Side Spoiler - Scratch - Small / (R) Front Door, Molding - Scratch - Small / (R) Mirror - Scratch - Minimal / (R) Front Fender, Molding - Scratch - Small / Front Bumper, Grille, Lamps - Scratch - Medium / Bonnet, Headlight - Scratch - Small / Roof - Scratch - Small </p> </div> |

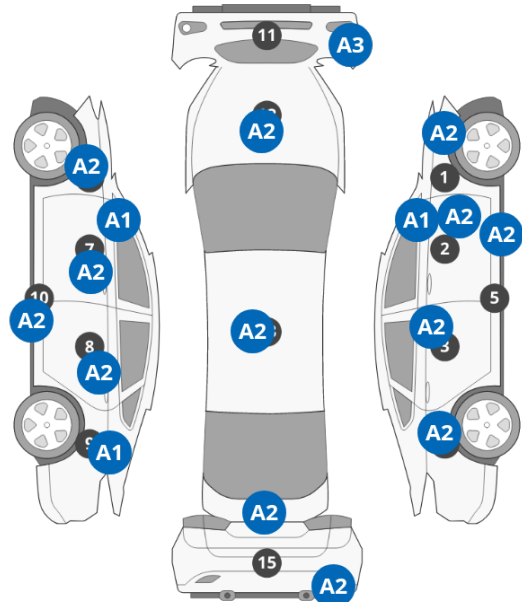
with LTO plate/no warranty booklet/no tools with jack/with worn spare tire/with spare key/splash of cement in the body/hairline scratches on the body/trunk floor matting missing
