## General Information

| Make | Toyota | Model | Fortuner |

## Body / Panel Condition

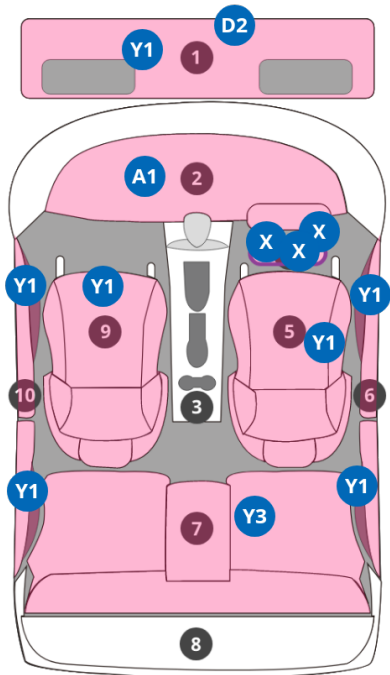
| Interior Evaluation : <span style="color: red;">B</span> | Exterior Evaluation : <span style="color: red;">B</span> |
| <b>Remarks</b><br>(L) Front Floor Mat - Missing - Yes / (R) Front Floor Mat - Missing - Yes / Mat Other - Missing - Yes / Dashboard - Worn, Scratch, Cut, Crack - Minimal / (L) Front Seat - Grime - Minimal / (R) Front Seat - Grime - Minimal / Rear Seat - Grime - Medium / Sunvisor, Sunglass Holder - Loose, Deformed - Small / Ceiling - Grime - Minimal / (L) Front Trim - Grime - Minimal / (R) Front Trim - Grime - Minimal / (L) Rear Trim - Grime - Minimal / (R) Rear Trim - Grime - Minimal | <b>Remarks</b><br>(R) Front Fender, Molding - Scratch - Minimal / (R) Front Door, Molding - Scratch - Minimal / (R) Rear Door, Molding - Scratch - Minimal / (R) Step, In-panel, Side Spoiler - Scratch - Minimal / (R) Rear Fender, Molding - Scratch - Minimal / Trunk Hood, Rear Gate - Scratch - Minimal / Rear Bumper, Lamps, Panels - Repair mark - Yes / (L) Rear Fender, Molding - Scratch - Minimal / (L) Rear Door, Molding - Scratch - Minimal / (L) Front Door, Molding - Scratch - Minimal / (L) Step, In-panel, Side Spoiler - Scratch - Minimal / (L) Front Fender, Molding - Scratch - Minimal / Front Bumper, Grille, Lamps - Repair mark - Yes / Bonnet, Headlight - Scratch - Minimal / Roof - Scratch - Minimal |
