## General Information

| Make | Toyota | Model | Hiace |
| Registration No. | NKN6562 | Chassis No. | JTFJT02P3S5039670 |

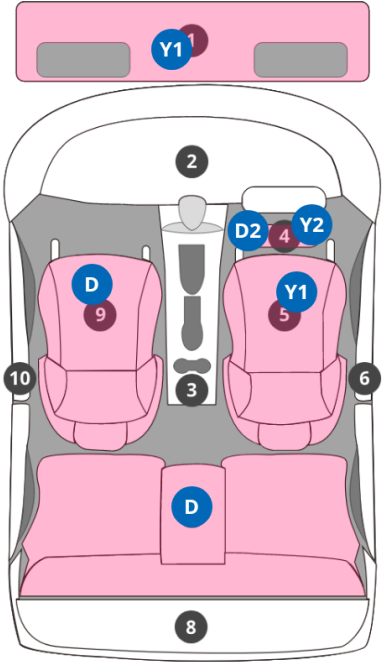
| Interior Evaluation : <span style="color: red;">B</span> | Exterior Evaluation : <span style="color: red;">C</span> |
| <b>Remarks</b><br>Ceiling - Grime - Minimal / (L) Front Floor Mat - Worked - Small / (R) Front Floor Mat - Grime - Small / Rear Seat - Worn - Yes / (R) Front Seat - Grime - Minimal / (L) Front Seat - Worn - Yes | <b>Remarks</b><br>Front Panel - Scratch - Minimal / (R) Front Fender, Molding - Scratch - Minimal / Front Bumper, Grille, Lamps - Scratch - Small / (R) Mirror - Scratch - Small / (R) Front Door, Molding - Scratch - Small / (R) Step, In-panel, Side Spoiler - Scratch & Dent - Small / (R) Rear Door, Molding - Scratch - Small / (R) Rear Fender, Molding - Scratch - Small / Trunk Hood, Rear Gate - Scratch & Dent - Medium / Rear Bumper, Lamps, Panels - Scratch - Small / (L) Rear Fender, Molding - Scratch & Dent - Small / (L) Front Door, Molding - Scratch - Minimal / (L) Step, In-panel, Side Spoiler - Scratch - Small / (L) Front Fender, Molding - Scratch - Minimal / Roof - Scratch - Small |

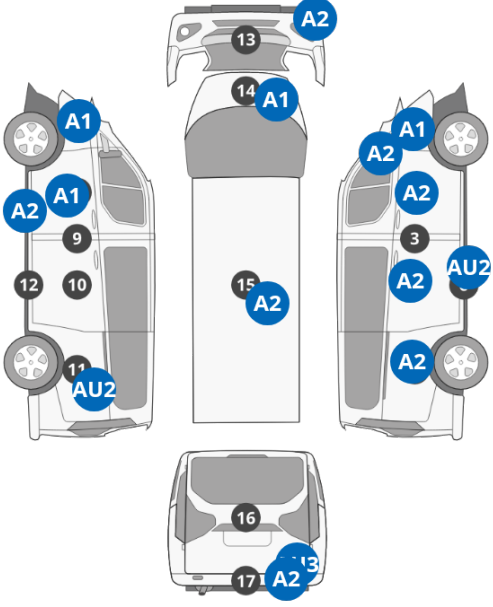
| Inspector Notes |
|---|
| with LTO plate/with warranty booklet/with incomplete tools with jack/with spare tire/no spare key/rear seats not installed/hairline scratches on the body |
