## General Information

| Make | Toyota | Model | Vios |
| YOM | 2023 | Odo Meter Reading | 34,220 |

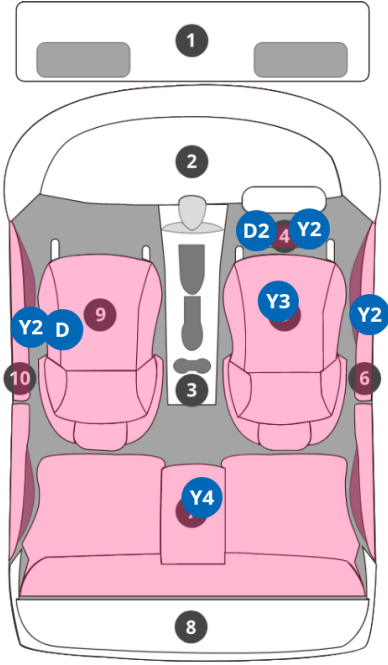
| Interior Evaluation : <span style="color: red;">C</span> | Exterior Evaluation : <span style="color: red;">D</span> |
|---|---|
| <b>Remarks</b><br>Rear Seat - Grime - Large / (R) Front Trim - Grime - Small / (R) Front Seat - Grime - Medium / (R) Front Floor Mat - Grime - Small / (L) Front Seat - Worn - Yes / (L) Front Floor Mat - Worked - Small / (L) Front Trim - Grime - Small | <b>Remarks</b><br>(L) Front Fender, Molding - Scratch - Minimal / (L) Mirror - Scratch - Minimal / (L) Front Door, Molding - Scratch - Small / (L) Step, In-panel, Side Spoiler - Scratch - Small / (L) Rear Door, Molding - Scratch - Small / (L) Rear Fender, Molding - Scratch & Dent - Small / Rear Bumper, Lamps, Panels - Scratch - Large / Trunk Hood, Rear Gate - Scratch & Dent - Large / (R) Rear Fender, Molding - Scratch & Dent - Small / (R) Rear Door, Molding - Scratch - Small / (R) Step, In-panel, Side Spoiler - Scratch - Small / (R) Front Door, Molding - Scratch & Dent - Minimal / (R) Front Fender, Molding - Scratch - Small / Bonnet, Headlight - Scratch & Dent - Minimal / Front Bumper, Grille, Lamps - Scratch - Medium / Roof - Scratch - Minimal |

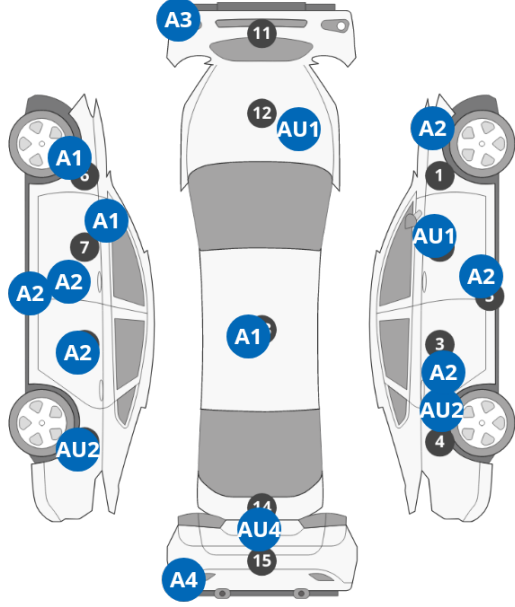
| Inspector Notes |
|---|
| with LTO plate/with warranty booklet/no tools and jack/with spare tire/with spare key/no reverse camera/tailight cover cracked/hairline scratches on the body |
