## General Information

| Make | Toyota | Model | Hiace |
| Registration No. | NKD3043 | Chassis No. | JTFJT02P9R0018300 |

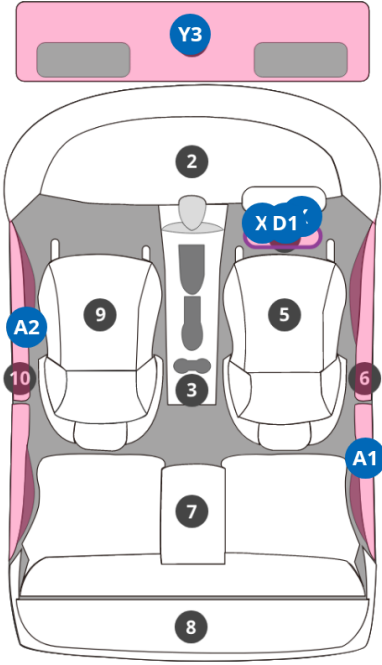
| Interior Evaluation : <span style="color: red;">B</span> | Exterior Evaluation : <span style="color: red;">E</span> |
|---|---|
| <b>Remarks</b><br>Ceiling - Grime - Medium / (R) Rear Trim - Cut, Crack - Minimal / (L) Front Floor Mat - Missing - Yes / (R) Front Floor Mat - Missing - Yes / Carpet - Worked - Minimal / (L) Front Trim - Cut, Crack - Small | <b>Remarks</b><br>(R) Front Door, Molding - Scratch & Dent - Small / (R) Front Fender, Molding - Scratch - Small / (R) Mirror - Scratch - Small / (R) Center Panel - Scratch & Dent - Small / (R) Rear Door, Molding - Scratch & Dent - Small / (R) Rear Fender, Molding - Scratch - Medium / Rear Bumper, Lamps, Panels - Scratch - Medium / Trunk Hood, Rear Gate - Scratch - Medium / (L) Rear Fender, Molding - Scratch & Dent - Small / (L) Rear Door, Molding - Scratch & Dent - Medium / (L) Front Fender, Molding - Scratch & Dent - Medium / (L) Front Door, Molding - Scratch - Medium / (L) Mirror - Scratch - Small / Front Bumper, Grille, Lamps - Scratch - Medium / Front Panel - Dent - Medium / Roof - Scratch - Minimal |
