## General Information

| Make | Toyota | Model | Wigo |

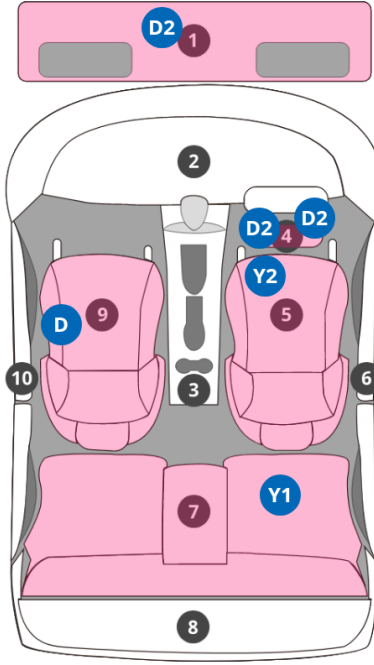
| Interior Evaluation : <span style="color: red; font-weight: bold;">B</span> | | Exterior Evaluation : <span style="color: red; font-weight: bold;">D</span> | |
| <p><b>Remarks</b></p> <p>(L) Front Seat - Worn - Yes / (R) Front Seat - Grime - Small / Rear Seat - Grime - Minimal / (L) Front Floor Mat - Worked - Small / (R) Front Floor Mat - Worked - Small / Ceiling - Crinkle - Small</p> | | <p><b>Remarks</b></p> <p>(R) Front Door, Molding - Scratch &amp; Dent - Large / (R) Front Fender, Molding - Scratch - Minimal / (R) Step, In-panel, Side Spoiler - Scratch - Small / (R) Rear Door, Molding - Scratch - Small / (R) Rear Fender, Molding - Scratch - Small / Rear Bumper, Lamps, Panels - Scratch - Minimal / Trunk Hood, Rear Gate - Scratch - Small / Roof - Scratch - Minimal / Bonnet, Headlight - Dent - Medium / Front Bumper, Grille, Lamps - Scratch - Medium / (L) Rear Fender, Molding - Scratch - Small / (L) Rear Door, Molding - Scratch - Small / (L) Front Door, Molding - Scratch - Small / (L) Mirror - Scratch - Minimal / (L) Front Fender, Molding - Scratch - Small / (R) Mirror - Scratch - Minimal</p> | |

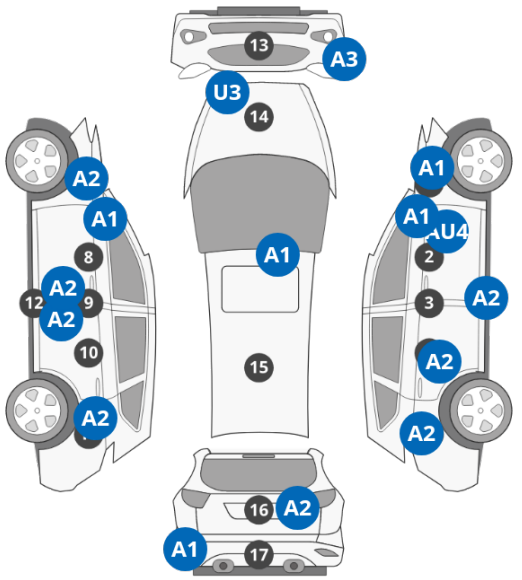
with warranty booklet, no jack and tools, with spare tire, with LTO plate, scratches on tail light
