## General Information

| Make | Toyota | Model | Vios |
| Registration No. | NFR7281 | Chassis No. | PA1B18F3XR4253374 |

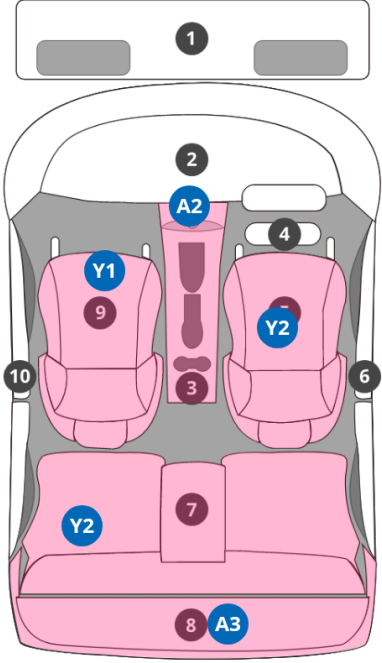
| <b>Interior Evaluation :</b> <span style="color: red; font-weight: bold;">B</span> | <b>Exterior Evaluation :</b> <span style="color: red; font-weight: bold;">C</span> |
| <b>Remarks</b><br>Knobs - Worn, Peel, Crack - Small / (L) Front Seat - Grime - Minimal / (R) Front Seat - Grime - Small / Rear Seat - Grime - Small / Trunk Room - Worn, Scratch, Cut, Crack - Medium | <b>Remarks</b><br>(R) Front Fender, Molding - Scratch & Dent - Medium / (R) Rear Door, Molding - Dent - Large / Trunk Hood, Rear Gate - Dent - Small / Rear Bumper, Lamps, Panels - Scratch - Large / Front Bumper, Grille, Lamps - Scratch - Small / (L) Rear Door, Molding - Scratch - Minimal / (L) Front Fender, Molding - Dent - Minimal / (L) Front Door, Molding - Scratch & Dent - Medium / (R) Front Door, Molding - Scratch - Medium |
