## General Information

| Make | Toyota | Model | Hilux |
| YOM | 2024 | Odo Meter Reading | 43,771 |
| Registration No. | NHH5058 | Chassis No. | MR0DB8CD0R0195105 |

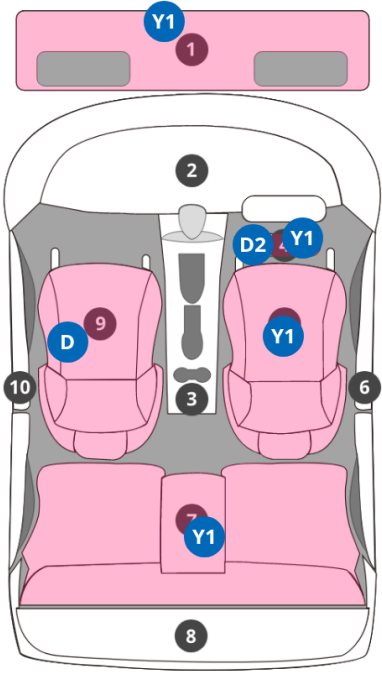
| Interior Evaluation : <b>B</b> | Exterior Evaluation : <b>C</b> |
|---|---|
| <p><b>Remarks</b></p> <p>Rear Seat - Grime - Minimal / (R) Front Seat - Grime - Minimal / (L) Front Seat - Worn - Yes / (R) Front Floor Mat - Grime - Minimal / (L) Front Floor Mat - Worked - Small / Ceiling - Grime - Minimal</p> | <p><b>Remarks</b></p> <p>(R) Front Door - Repair Traces - Yes / (L) Front Door - Repair Traces - Yes / (R) Front Door, Molding - Repair mark - Yes / (L) Front Door, Molding - Repair mark - Yes / (L) Rear Door, Molding - Repair mark - Yes / (L) Step, In-panel, Side Spoiler - Scratch - Small / (L) Front Fender, Molding - Scratch - Minimal / (L) Front Door, Molding - Scratch - Small / (L) Rear Door, Molding - Scratch - Small / (L) Side Gate - Scratch &amp; Dent - Medium / Rear Bumper, Lamps, Panels - Scratch - Minimal / Rear Gate - Scratch - Minimal / (R) Rear Door, Molding - Scratch - Small / (R) Front Fender, Molding - Scratch - Small / Front Bumper, Grille, Lamps - Scratch - Medium / Bonnet, Headlight - Scratch &amp; Dent - Minimal / Roof - Scratch - Minimal / Cargo Bed Floor - Scratch - Minimal / (R) Front Door, Molding - Scratch - Minimal / (R) Side Gate - Scratch - Minimal / (R) Step, In-panel, Side Spoiler - Scratch - Minimal</p> |
