## General Information

| Make | Toyota | Model | Hilux Tamaraw |
| YOM | 2026 | Odo Meter Reading | 5,615 |
| Registration No. | NLC3876 | Chassis No. | PAHACACA7S6431737 |

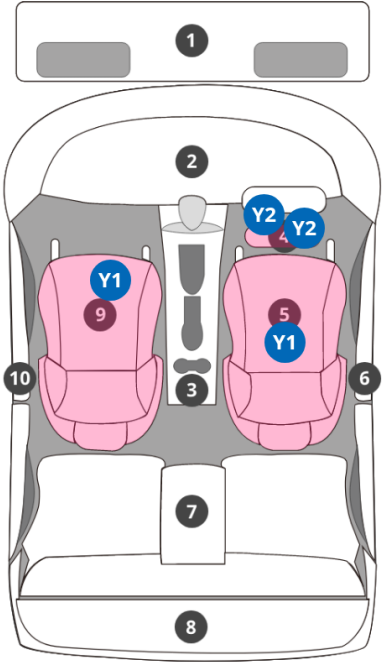
| Interior Evaluation : <b>A</b> | Exterior Evaluation : <b>B</b> |
|---|---|
| <p><b>Remarks</b><br/>(R) Front Seat - Grime - Minimal / (L) Front Seat - Grime - Minimal / (R) Front Floor Mat - Grime - Small / (L) Front Floor Mat - Grime - Small</p> | <p><b>Remarks</b><br/>(R) Side Gate - Scratch - Small / (R) Step, In-panel, Side Spoiler - Scratch - Small / (R) Front Door, Molding - Scratch - Minimal / (R) Mirror - Scratch - Minimal / (R) Front Fender, Molding - Scratch - Minimal / Front Bumper, Grille, Lamps - Scratch - Small / Bonnet, Headlight - Scratch - Minimal / (L) Front Fender, Molding - Scratch - Minimal / (L) Step, In-panel, Side Spoiler - Scratch - Small / (L) Front Door, Molding - Scratch - Minimal / Roof - Scratch - Minimal / (L) Side Gate - Scratch - Minimal / Cargo Bed Floor - Scratch - Small / Rear Gate - Scratch - Minimal / Rear Bumper, Lamps, Panels - Scratch - Small</p> |

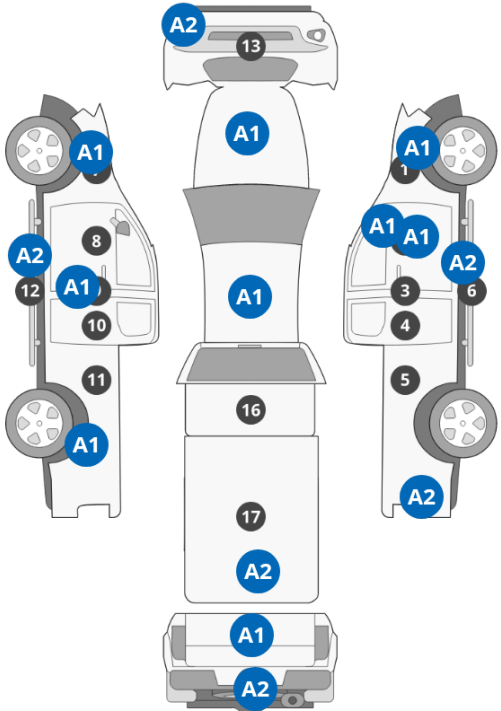
| Inspector Notes |
|---|
| with LTO plate/with warranty booklet/with tools and jack/with spare tire/with spare key/with seat cover/hairline scratches on the body |
