## General Information

| Make | Toyota | Model | Avanza |
| Registration No. | DCC1942 | Chassis No. | MHFAA1BY0S0053797 |

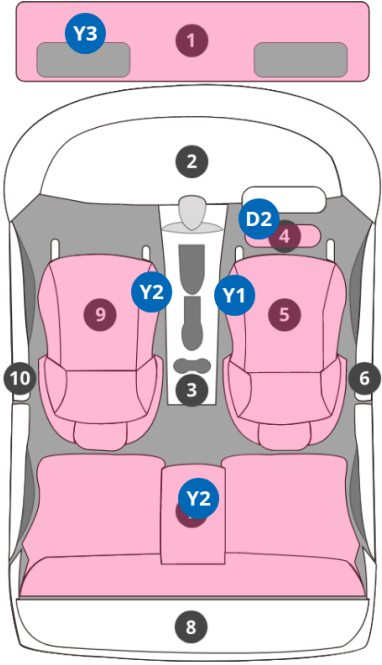
| Interior Evaluation : <b>B</b> | Exterior Evaluation : <b>C</b> |
|---|---|
| <p><b>Remarks</b><br/>(L) Front Floor Mat - Worked - Small / (L) Front Seat - Grime - Small / Rear Seat - Grime - Small / (R) Front Seat - Grime - Minimal / Ceiling - Grime - Medium</p> | <p><b>Remarks</b><br/>(R) Mirror - Scratch - Minimal / (R) Front Fender, Molding - Scratch - Minimal / (R) Front Door, Molding - Scratch &amp; Dent - Small / (R) Rear Door, Molding - Scratch - Minimal / (R) Step, In-panel, Side Spoiler - Scratch - Minimal / (R) Rear Fender, Molding - Scratch - Small / Rear Bumper, Lamps, Panels - Scratch - Medium / Trunk Hood, Rear Gate - Scratch - Minimal / (L) Rear Fender, Molding - Scratch - Minimal / (L) Rear Door, Molding - Scratch - Minimal / (L) Front Door, Molding - Scratch - Minimal / (L) Mirror - Scratch - Minimal / (L) Front Fender, Molding - Scratch - Minimal / Front Bumper, Grille, Lamps - Scratch - Medium / Bonnet, Headlight - Scratch - Small / Roof - Scratch - Minimal</p> |

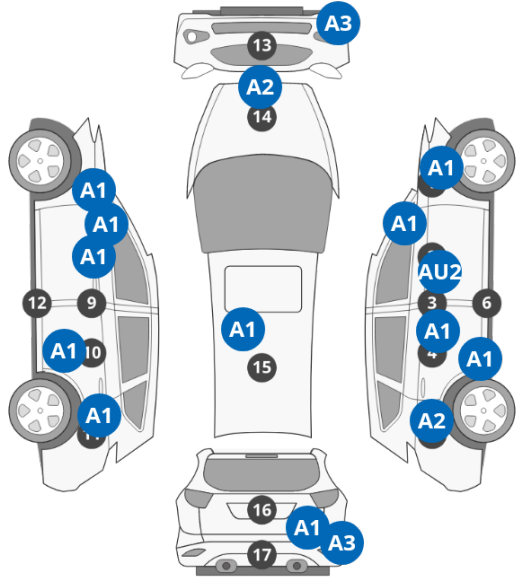
| Inspector Notes |
|---|
| with warranty booklet, jack and tools, with spare tire, with LTO plate, scratches on tail light |
