## General Information

| Make | Toyota | Model | Hilux Tamaraw |
| Registration No. | NJK2045 | Chassis No. | PAHACACA4S6428066 |

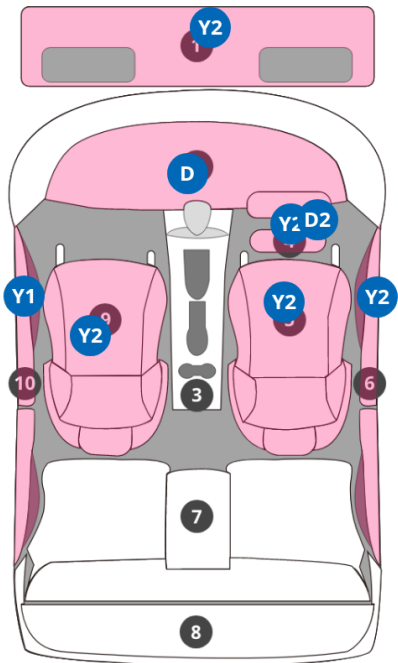
| Interior Evaluation : <b>B</b> | Exterior Evaluation : <b>D</b> |
| <b>Remarks</b><br>(R) Front Seat - Grime - Small / (L) Front Floor Mat - Grime - Small / (R) Front Floor Mat - Crinkle - Small / (L) Front Seat - Grime - Small / Ceiling - Grime - Small / (R) Front Trim - Grime - Small / (L) Front Trim - Grime - Minimal / Dashboard - Traces of Adhesive Tape - Yes | <b>Remarks</b><br>(L) Front Door, Molding - Scratch - Medium / (L) Front Fender, Molding - Scratch & Dent - Medium / (L) Step, In-panel, Side Spoiler - Scratch & Dent - Small / Roof - Scratch & Dent - Minimal / (L) Side Gate - Scratch & Dent - Small / (L) Guard Frame - Scratch & Dent - Small / Rear Bumper, Lamps, Panels - Scratch - Small / (R) Guard Frame - Scratch & Dent - Medium / Cab Back Panel - Scratch & Dent - Large / (R) Front Door, Molding - Scratch & Dent - Small / (R) Step, In-panel, Side Spoiler - Scratch & Dent - Minimal / (R) Front Fender, Molding - Scratch - Small / Bonnet, Headlight - Scratch & Dent - Minimal / Front Bumper, Grille, Lamps - Scratch - Small |

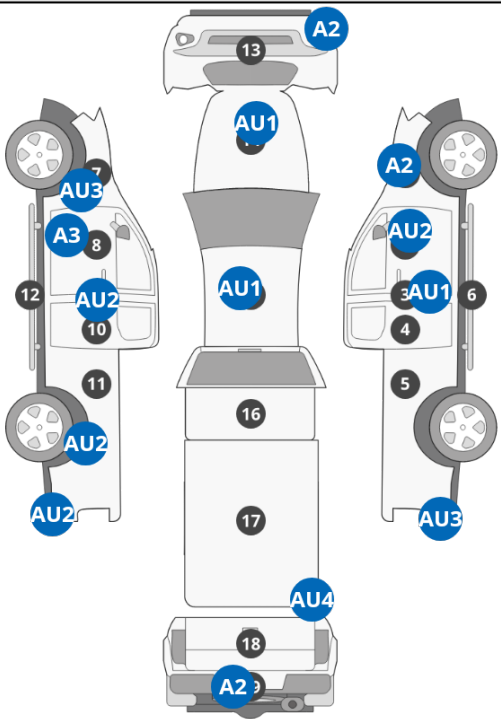
| Inspector Notes |
|---|
| with LTO plate, with spare tire, with warranty and manual booklet, with jack, scratches in taillight and headlight, no spare key, scratches and dent on exterior. |
