## General Information

| Make | Toyota | Model | Hilux Tamaraw |

## Body / Panel Condition

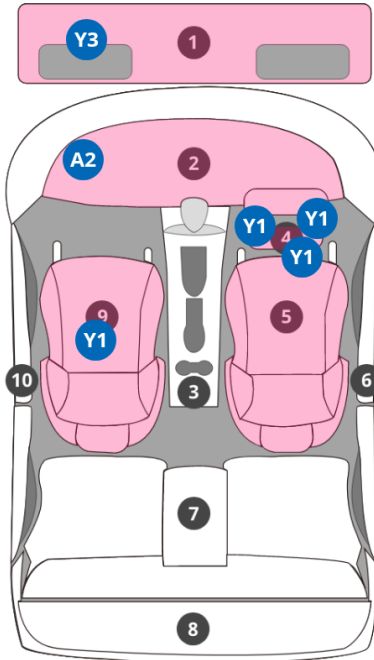
| Interior Evaluation : <span style="color: red; font-weight: bold;">B</span> | | Exterior Evaluation : <span style="color: red; font-weight: bold;">C</span> | |
| <p><b>Remarks</b></p> <p>Dash-board - Worn, Scratch, Cut, Crack - Small / (R)<br/> Front Seat - Grime - Minimal / (L) Front Seat - Grime - Minimal / (L) Front Floor Mat - Grime - Minimal / (R) Front Floor Mat - Grime - Minimal / Ceiling - Grime - Medium</p> | | <p><b>Remarks</b></p> <p>(R) Front Fender, Molding - Scratch - Minimal / (R) Mirror - Scratch - Minimal / (R) Front Door, Molding - Scratch - Small / (R) Side Gate - Scratch &amp; Dent - Medium / Rear Gate - Scratch - Minimal / Cargo Bed Floor - Scratch &amp; Dent - Large / (L) Side Gate - Scratch - Minimal / (L) Front Door, Molding - Scratch - Minimal / (L) Step, In-panel, Side Spoiler - Scratch - Minimal / (R) Step, In-panel, Side Spoiler - Scratch - Minimal / (L) Front Fender, Molding - Scratch - Minimal / Bonnet, Headlight - Scratch - Minimal / Front Bumper, Grille, Lamps - Scratch - Minimal / Roof - Scratch - Minimal</p> | |
