## General Information

| Make | Toyota | Model | Hilux Tamaraw |

## Body / Panel Condition

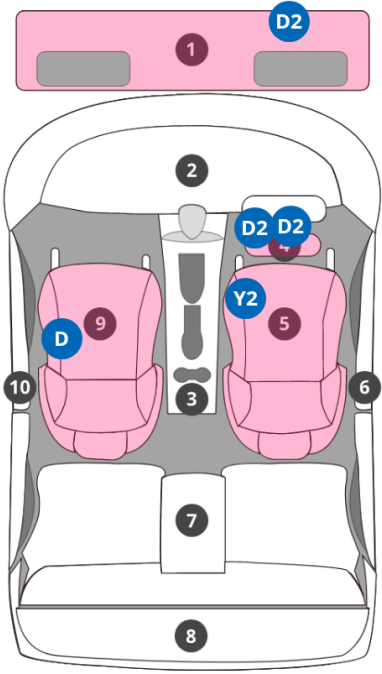
| Interior Evaluation : <b>B</b> | Exterior Evaluation : <b>E</b> |
|---|---|
| <p><b>Remarks</b><br/>(R) Front Seat - Grime - Small / (L) Front Seat - Worn - Yes / Ceiling - Crinkle - Small / (L) Front Floor Mat - Worked - Small / (R) Front Floor Mat - Worked - Small</p> | <p><b>Remarks</b><br/>(R) Front Fender, Molding - Scratch &amp; Dent - Medium / (R) Front Door, Molding - Scratch &amp; Dent - Medium / (R) Mirror - Scratch - Small / Cargo Bed Floor - Scratch &amp; Dent - Large / Cab Back Panel - Scratch &amp; Dent - Large / Rear Bumper, Lamps, Panels - Scratch - Small / Rear Gate - Scratch - Medium / (L) Side Gate - Scratch - Medium / (R) Side Gate - Scratch - Medium / (L) Mirror - Scratch - Small / (L) Front Door, Molding - Scratch - Small / (L) Front Fender, Molding - Scratch - Small / Front Bumper, Grille, Lamps - Scratch &amp; Dent - Medium / Bonnet, Headlight - Scratch - Small / Roof - Scratch &amp; Dent - Small</p> |

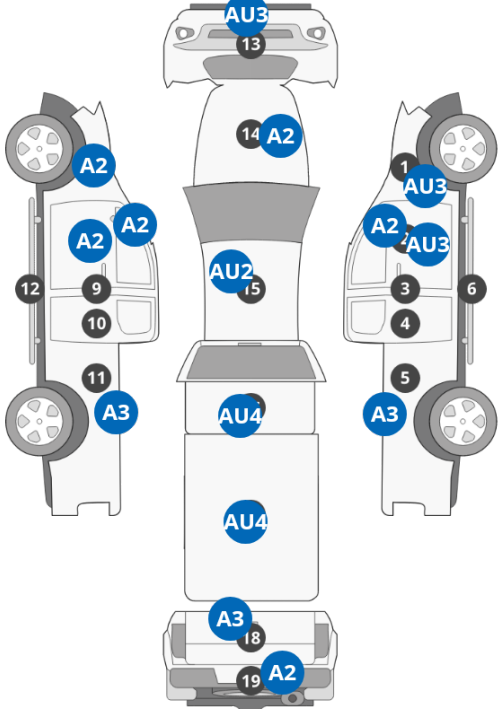
no warranty booklet, with jack, no tools, with spare tire, with LTO plate, scratches on tail light, daytime running light issue, watermarks on headlight
